St Pius X Hall
Functional and Physical Condition Assessment
by
St Pius X Building & Maintenance Committee

This report is intended to provide an overview of the general condition of the parish hall for the purpose of providing Parish Council with information necessary to inform their decisions on future plans for the hall. The facility assessment was undertaken by the parish Building Maintenance Committee (BMC) comprised of individuals having professional experience in relevant engineering disciplines but is not intended to replace a detailed engineering investigation of the facility and component systems.

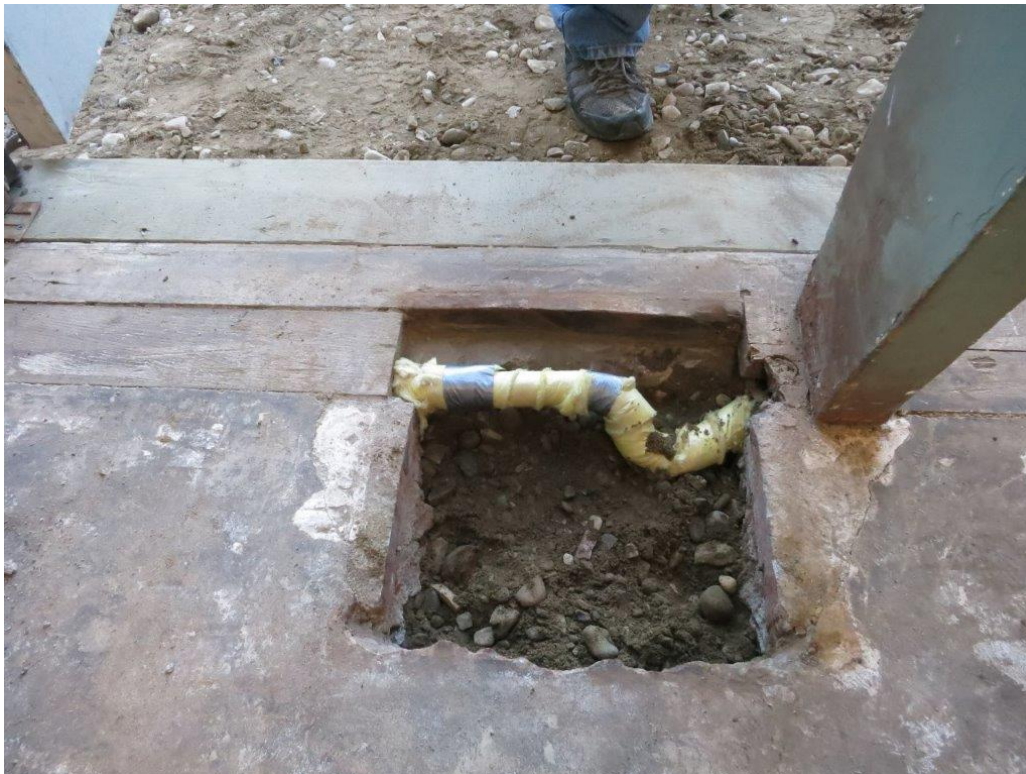
The hot water uninsulated heating pipes run under the floor slab **under the arch rib connection to the concrete floor slab.**

Photo 8 - Arch rib to edge of concrete slab on grade floor/foundation. (Note pipe has been insulated in this one location only)

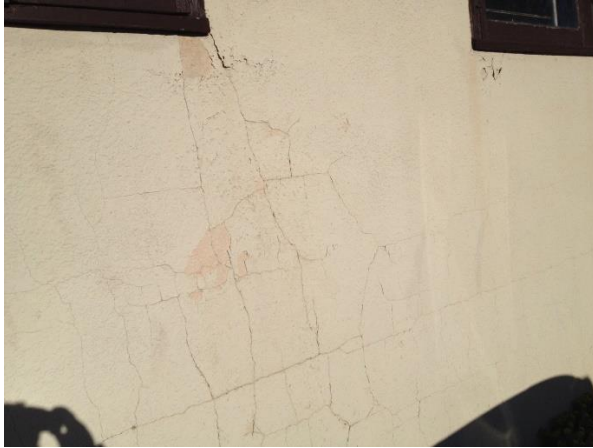
Photo 9 - Exterior of the Hall – Paint layer over stucco is falling off and cracks are forming in stucco

The exterior paint on the stucco was tested and found to contain lead.

The paint layer over the stucco is falling off and cracks are forming in stucco.

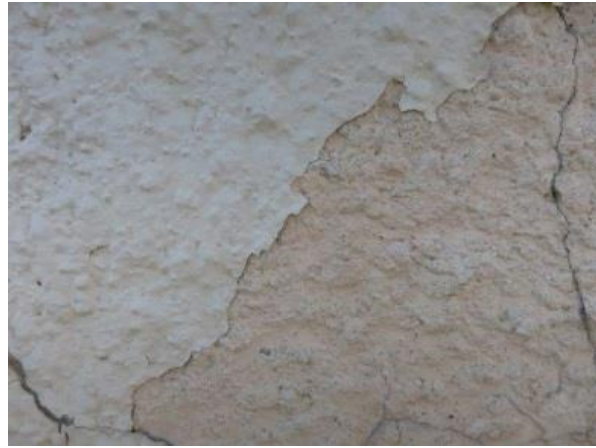
Photo 10 - Peeling Paint and Cracks in Underlying Stucco

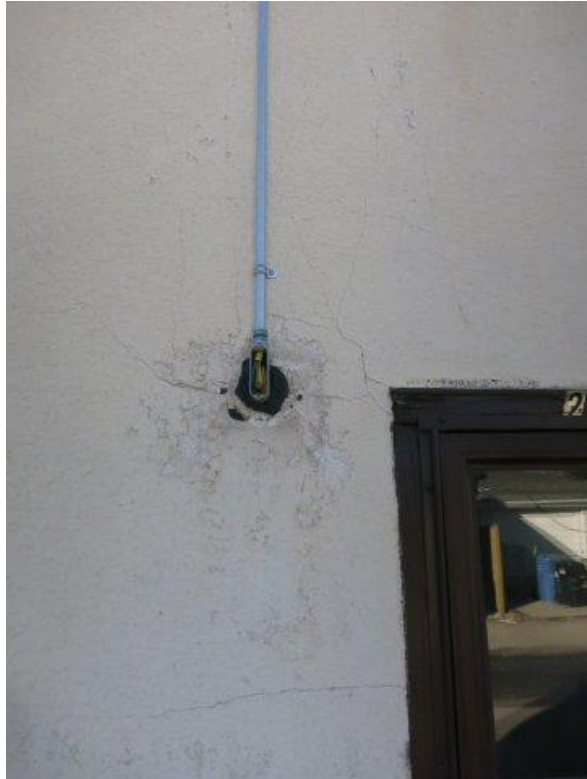
Blanked openings for electrical wiring fixtures and other devices are not sealed against water entry. Such instances are found on all walls.

Photo 11 - Open Electrical Conduit Penetration through the Stucco Wall

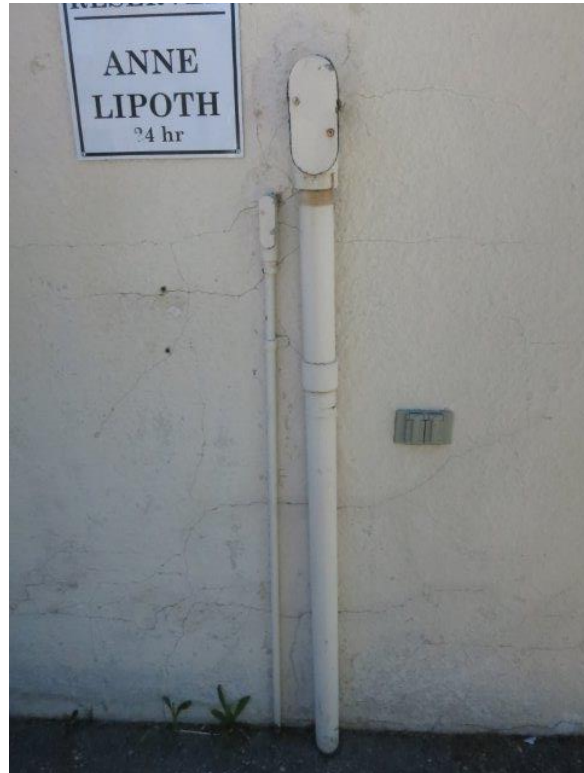
Photo 12 - Holes in Stucco not Sealed

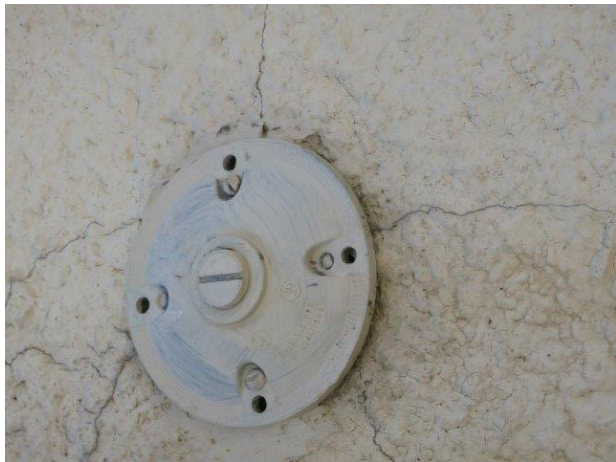
Photo 14 - Improperly Covered and Sealed Electrical Fittings

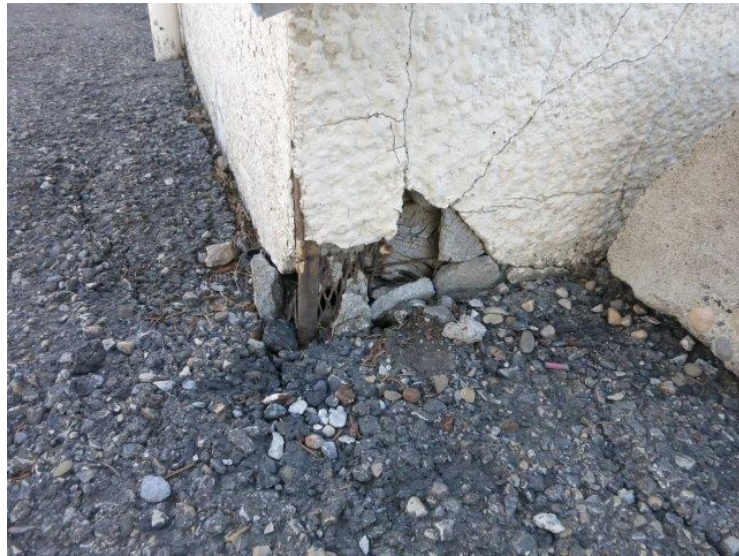
A part of the west and north walls is now below grade. Damaged stucco has allowed wall framing, plaster lath and the interior wall to be exposed to the outside and to surface ground and rain water. Such damage provides a potential ingress location for mice as well as water to further damage the corners of the building.

Photo 16 - Damage to Hall Corner. Note Wall is Below Surface at this Location

Correction of this issue will require lowering the ground and asphalt surfaces, implementing drainage in this area and re-contouring of the pavement at the north end of the hall. Only then could the interior wall damage be corrected. **Drainage along the entire west wall is an issue and is not consistent with positive drainage of runoff away from the building (see section 12 for additional comments pertaining to site grading issues).**

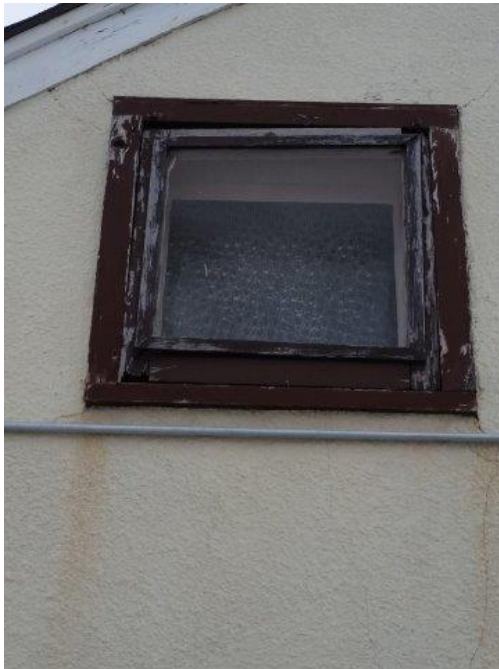
Doors and windows and their associated framing on the north end of the hall have rotted. The interior wall studs are visible in several rot openings.

Photo 17 - Window in North wall of Upper Bedroom (now office) with Rotted Frame

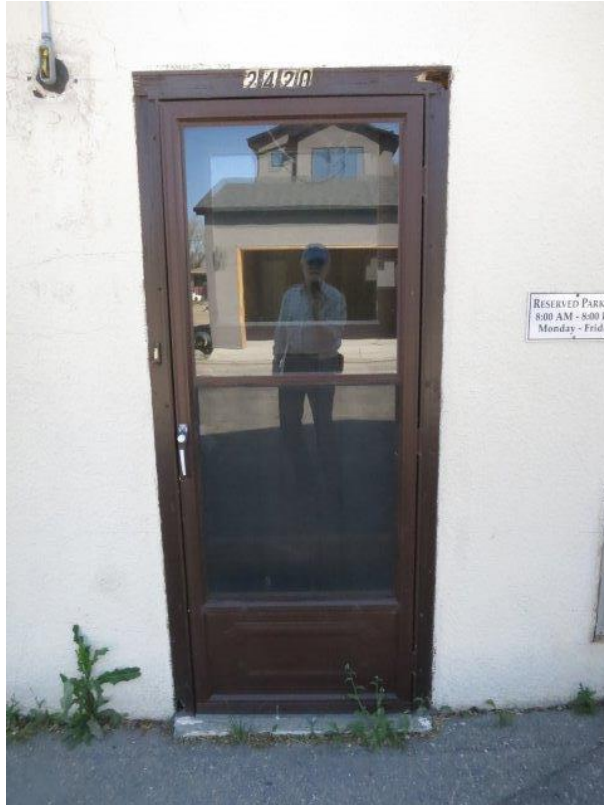
Photo 19 - North End door With very Rotted Frame

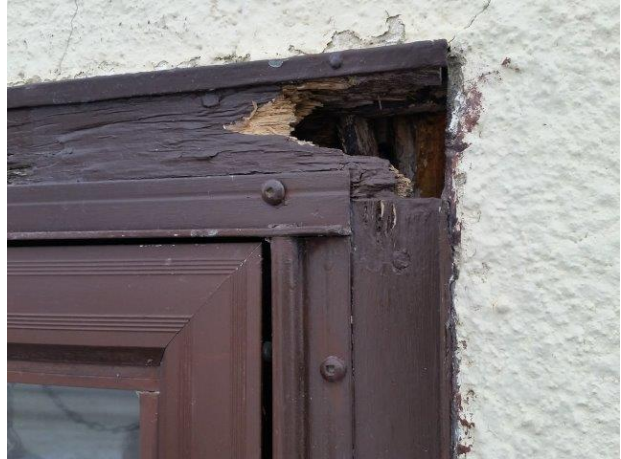
Photo 20 - North Door Frame Rot

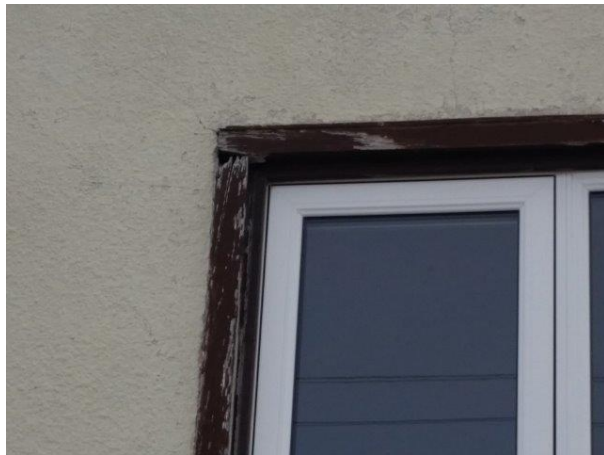
Photo 21 - Rotted Frames around Replacement Thermopane Sealed Window Units

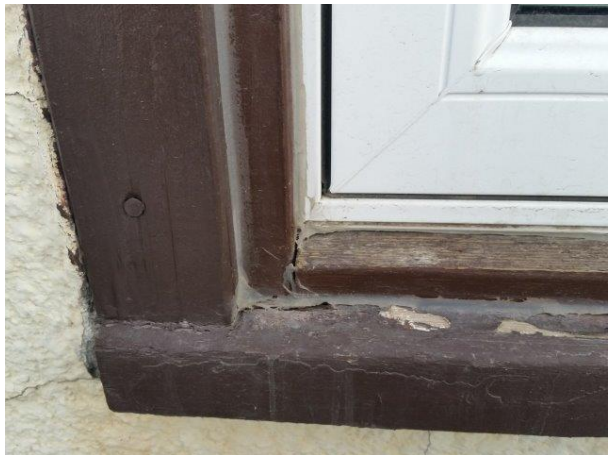
Photo 22 - Rotted Frames around Replacement Sealed Window Units

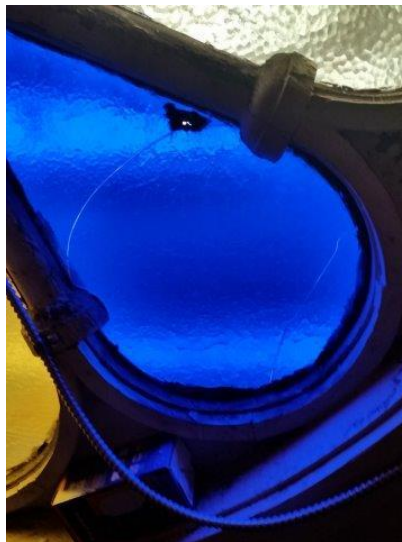
Photo 25 - Broken Single-Pane glass in Circular Window

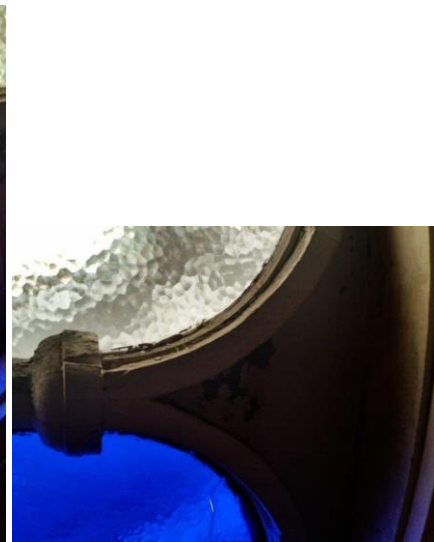
Photo 26 - Rotted Wood in Hand Built Stained Glass Window

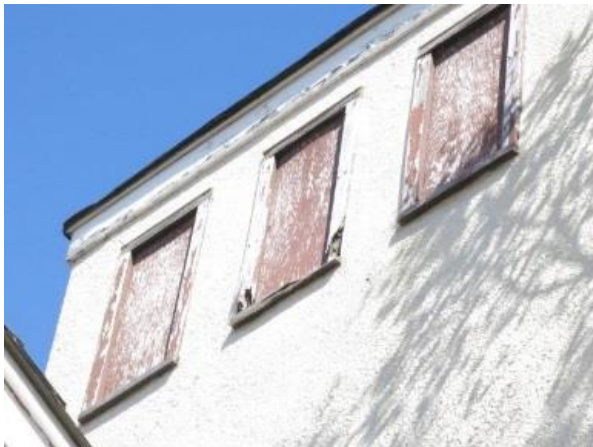
Openings are either blanked (with rotten plywood) or screened poorly (with torn or missing screening) allowing rain water, birds, bats and perhaps mice into tower cavity. There is some water damage to the framing members of the tower, with several broken.

Photo 38 - Blank Windows on Faux Bell Tower

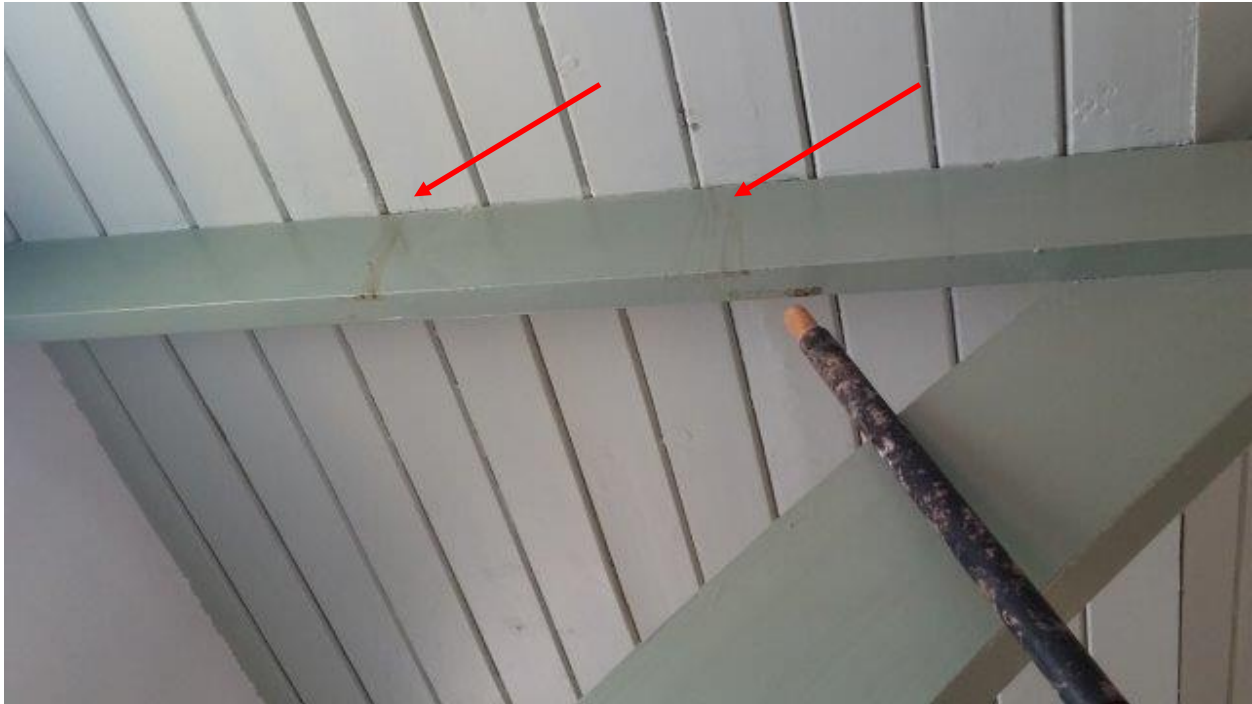
The roof framing (arches) is mostly exposed throughout the hall area and were examined at a few locations. Members were typically painted and were found to exhibit minor cracking (checking) at laminations (photo) but no obvious signs of distress were apparent. The connection of the arches to the sill plate were mostly concealed by finishes and heating cabinets at the base of the exterior walls. The condition of the sill plate was partially visible at a few locations, however, and the painted finish was found to be cracked suggestive of possible water damage (photo 40).

accommodate electrical, plumbing and heating services in walls]. The minimal roof insulation results in significant thermal loss through the roof, causing snow to melt and fill the eaves trough, and then freeze causing eaves trough failure and risk of falling ice injuring someone. It has also caused water to start to leak through the roof to the building interior or to back up under the shingles and then through the interior planked deck of the roof. The roof leaks to the interior were observed at the time of recent interior painting. The leaks are generally at the junction of the curved and flat portions of the interior ceiling portion of the roof.

Photo 40 - Water Leakage on the Interior/Underside of the Roof

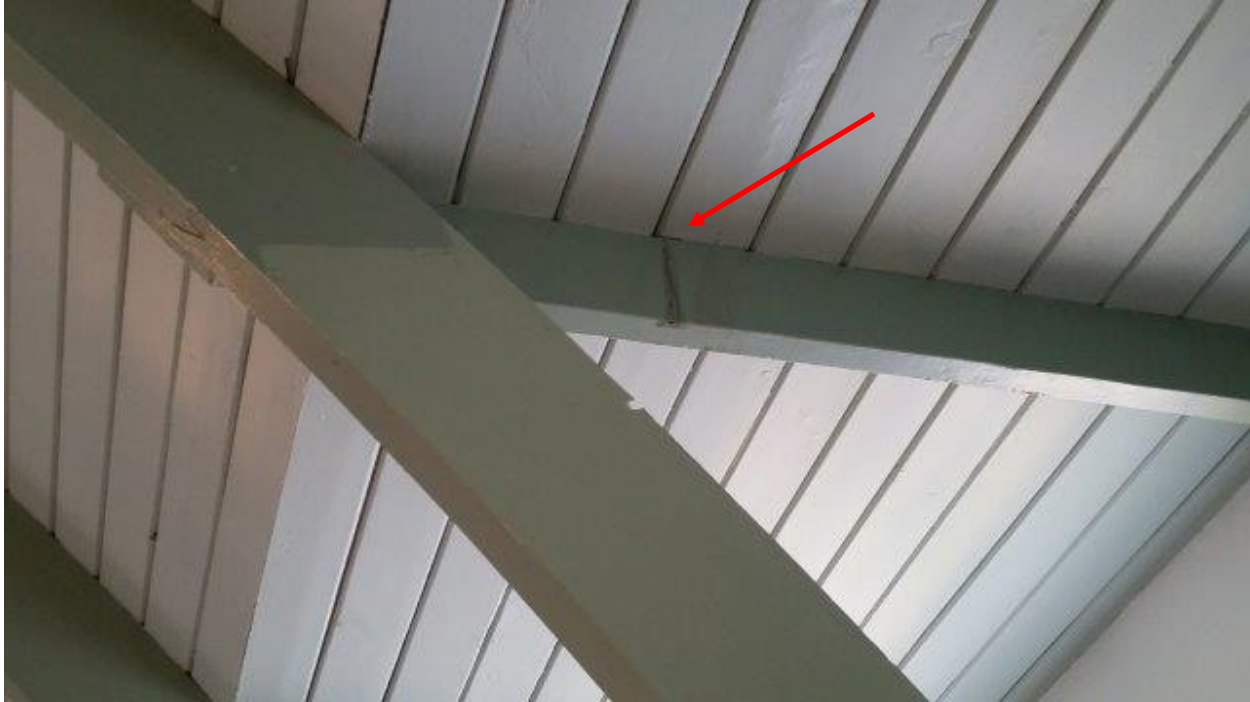
Photo 41 - Water Leakage on the Interior/Underside of the Roof

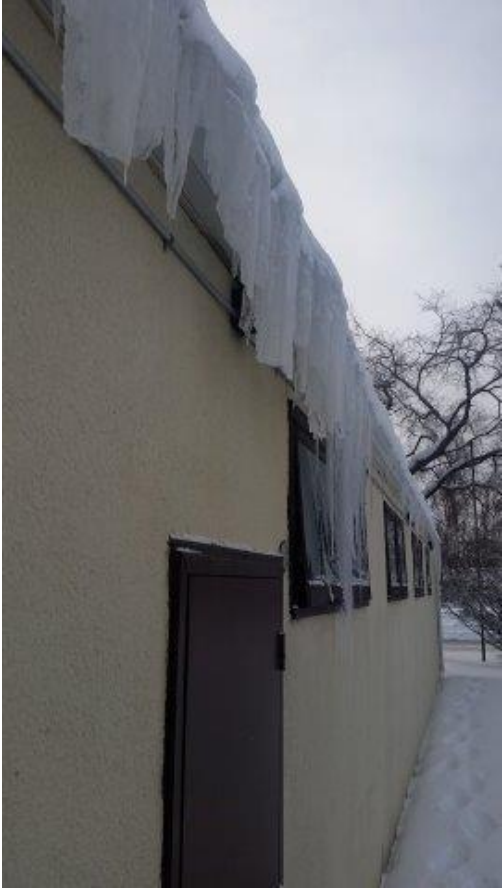
The eaves troughs and fascia have required persistent repairs due to stresses created by the roof design, and ice buildup resulting from the heat loss through the roof. This is a difficult problem to resolve.

Photo 42 - Icicles along West Wall of Hall

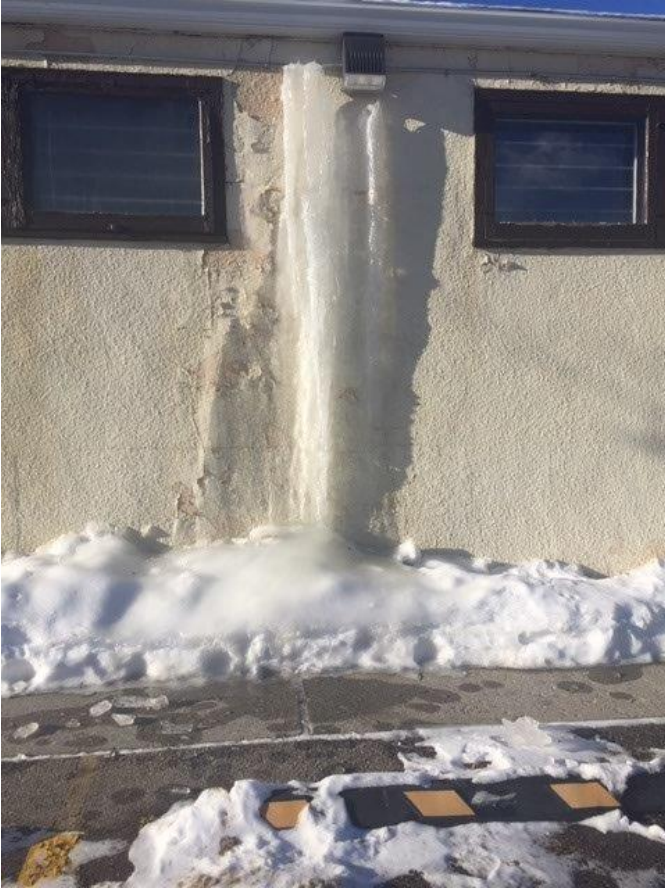
Photo 43 - Icicles along East Wall of Hall

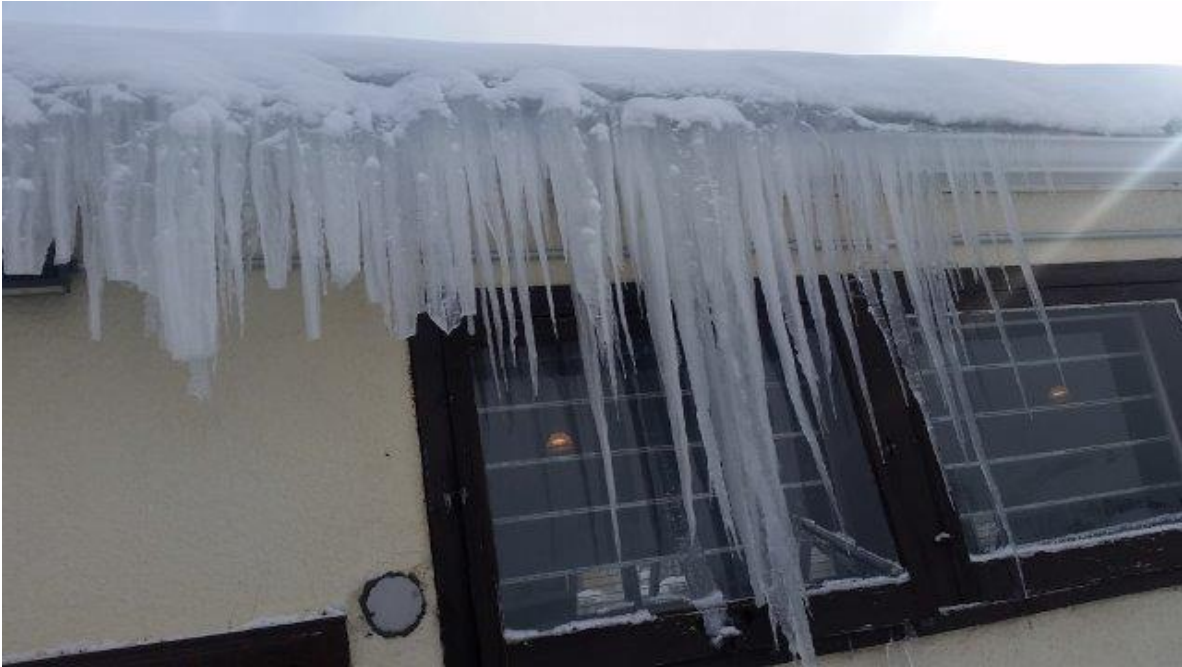
Photo 44 - Icicles along West Walls of Hall. Icicles from melted Snow on Poorly Insulated Roof

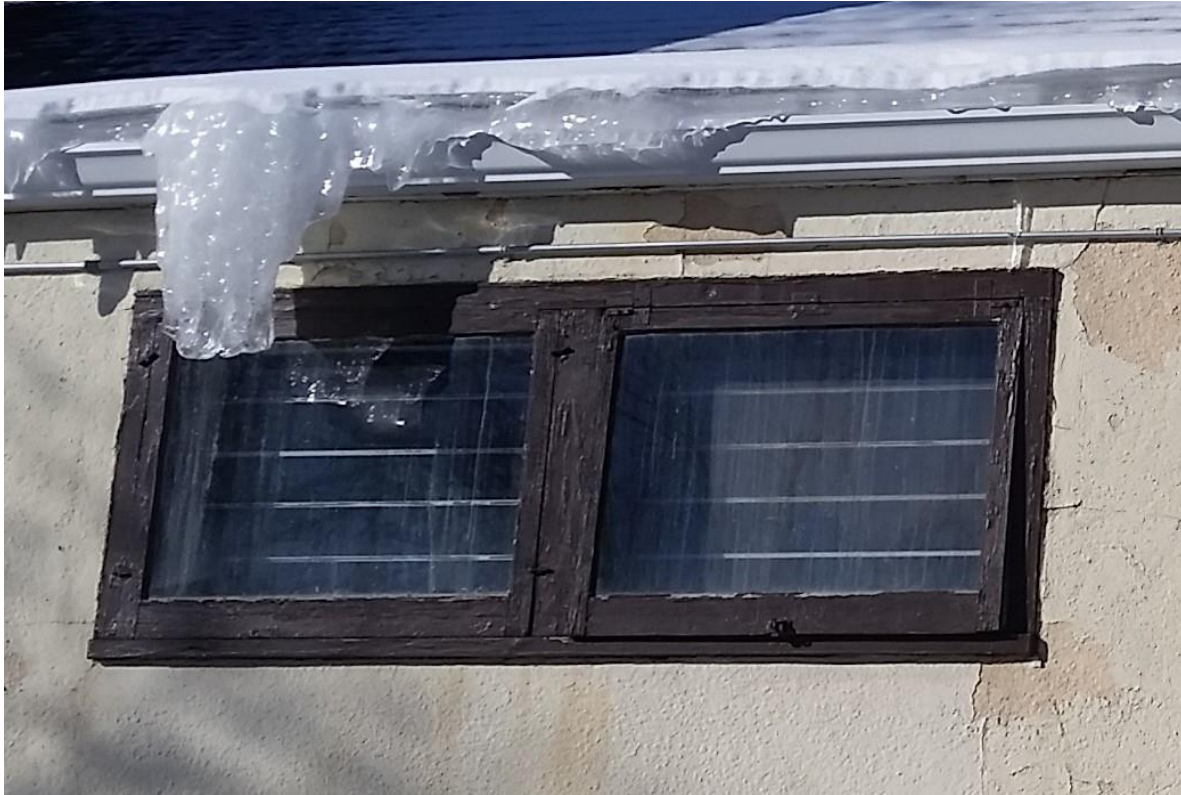
Photo 45 - Icicles along West Walls of Hall. Icicles from melted Snow on Poorly Insulated Roof. Note Window that will Not Close.

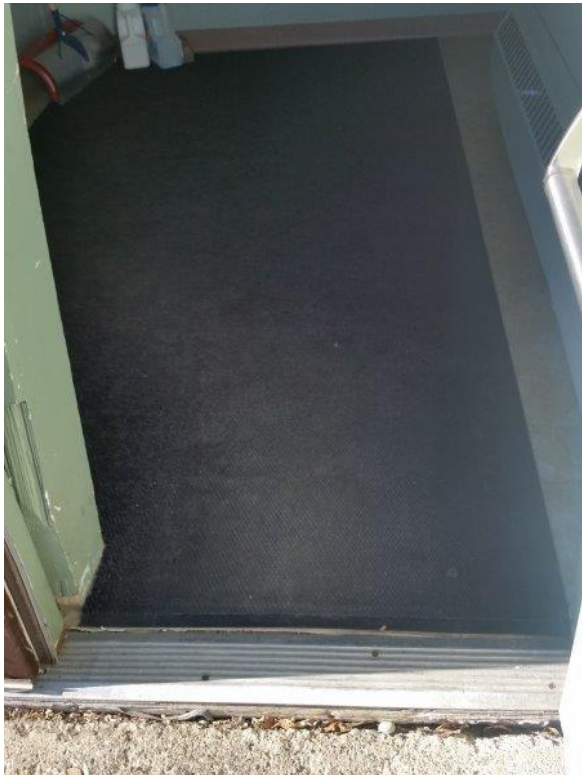
Photo 52 - Damaged Door Sill, Subsiding Door Ramp

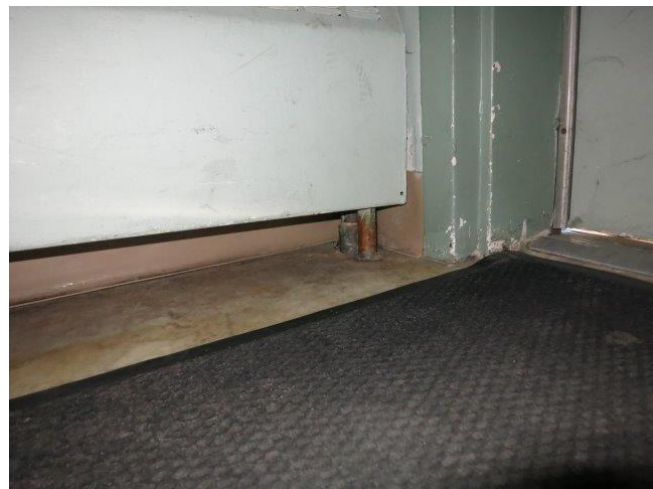
Photo 53 - Deteriorated Floor Covered with Matting; Note Light Under Left Edge of Door

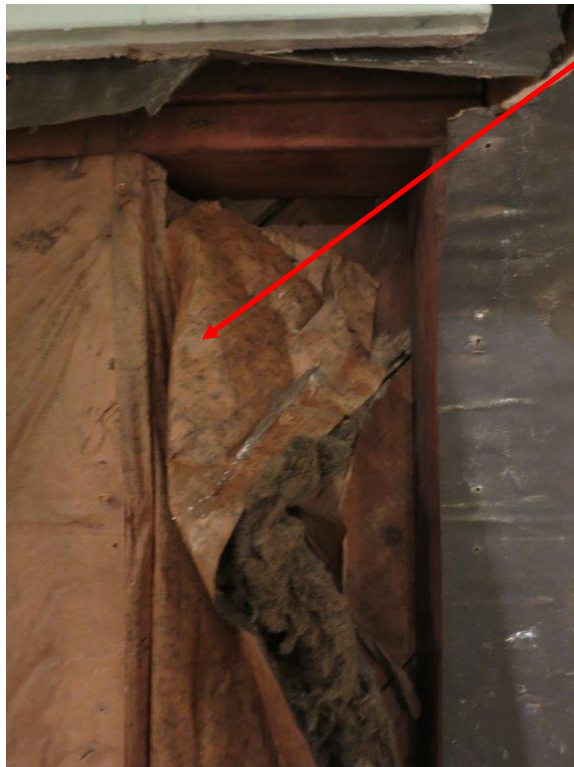
The insulation is approximately two (2) inches thick providing no more than R6 insulation; however, it has places, at least under the examined windows, where the insulation does not even completely cover the outside wall.

Photo 54 - Wall Insulation that is Sagging, Unsupported and Incompletely Covering Wall

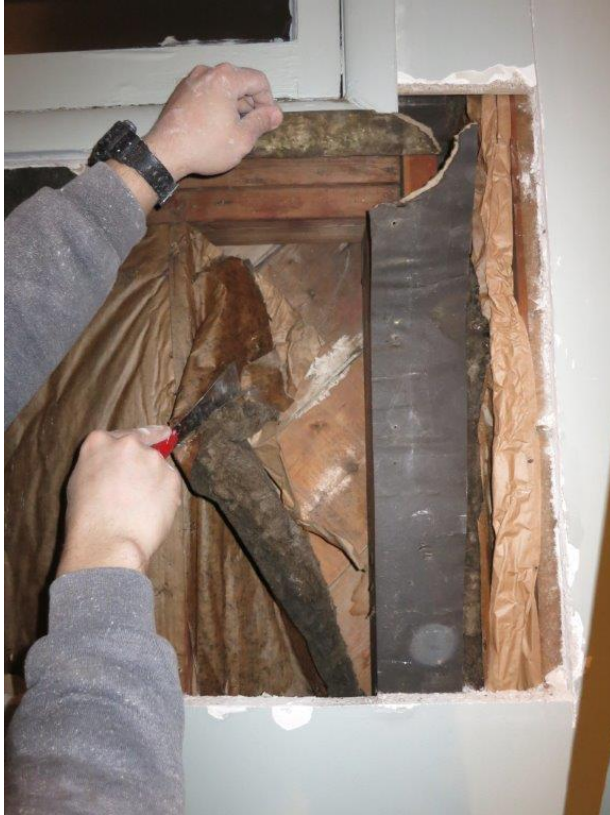
Photo 56 - Top right side of west wall under window. Minor damage on outside wood sheathing. Very incomplete vapour barrier. Tar paper over double framing members.

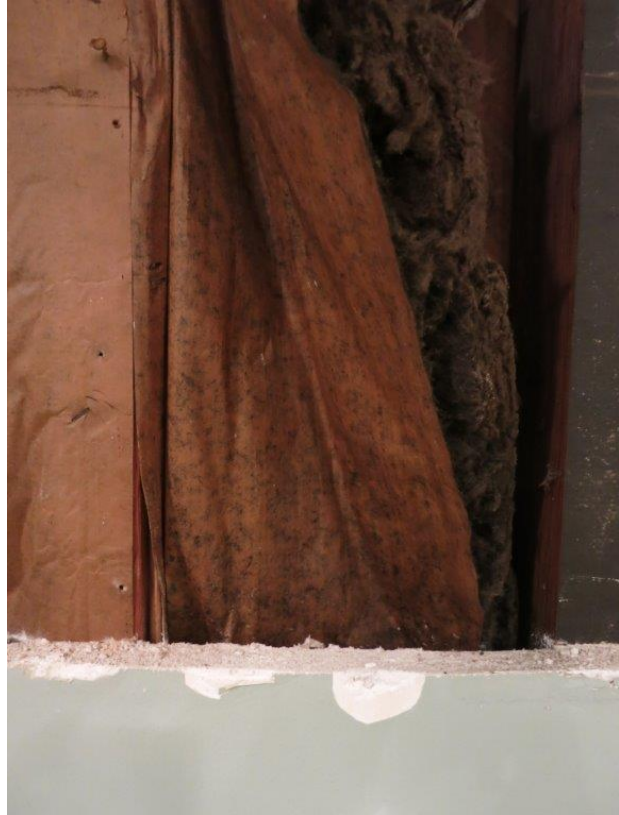
Photo 57 - Mould on Paper-Backed Insulation in Wall Cavity

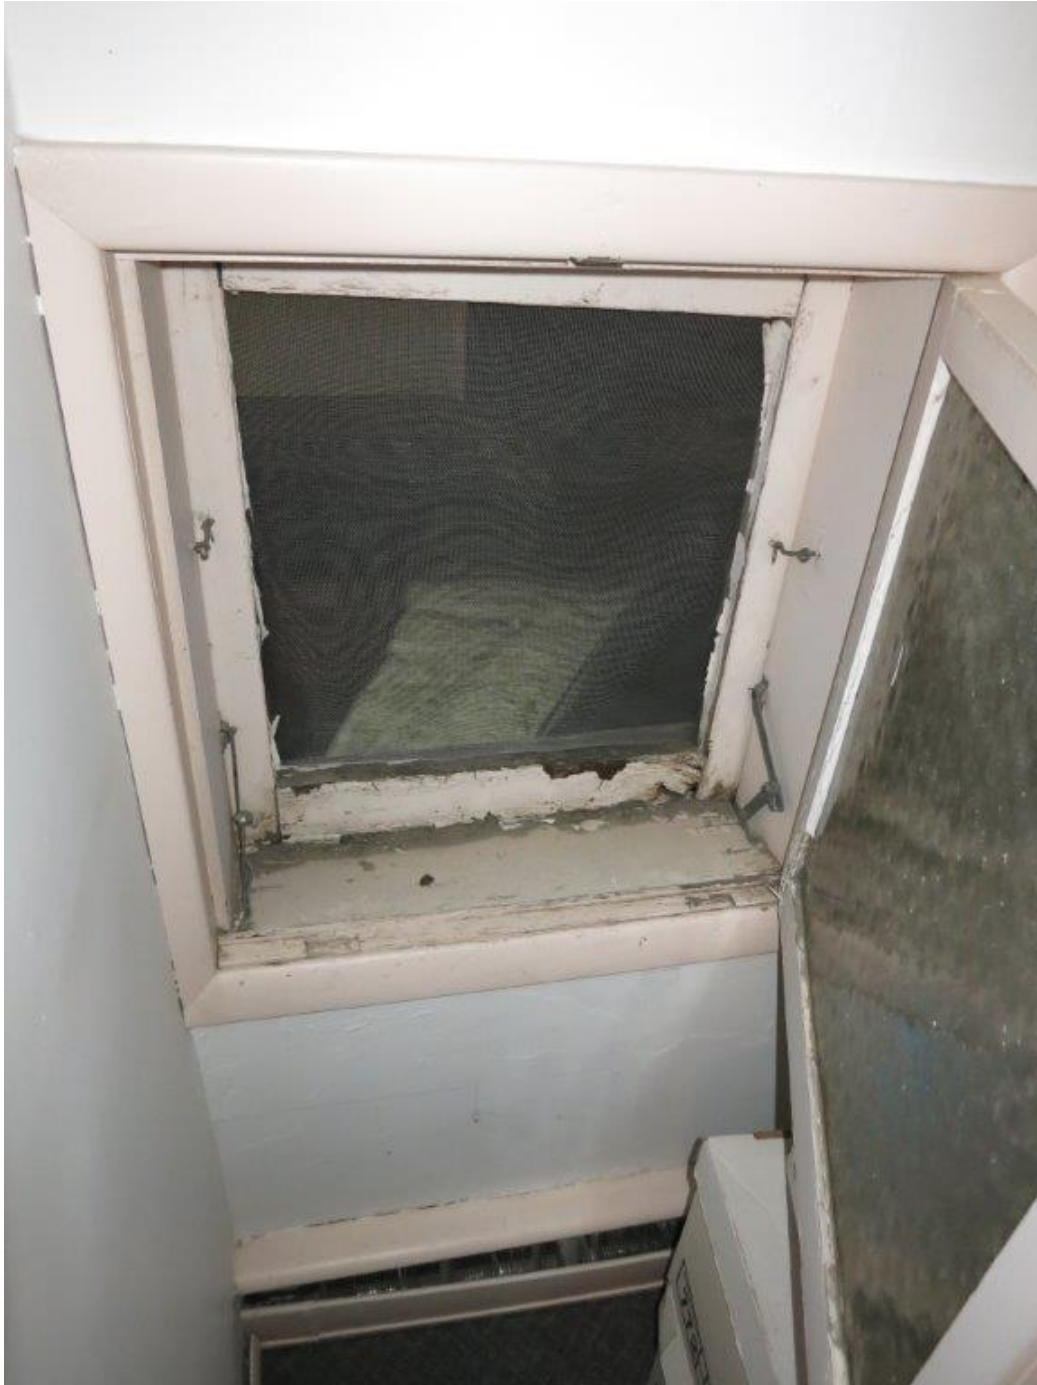
mould/trim are in dire need of replacement.

Photo 68 - Upper Office Original Window

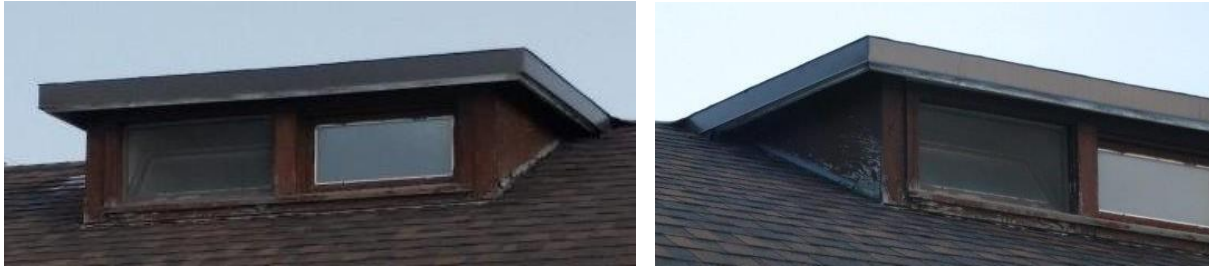
The upper office has a double “look-out” window providing light to the original bedroom and stair areas. This window is also showing considerable signs of deterioration.

Photo 69 - Upper office "Look-out" Window

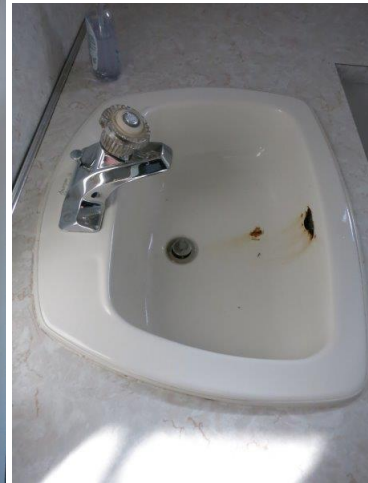
Photo 75 - Deteriorating Fixtures in Women's Washroom

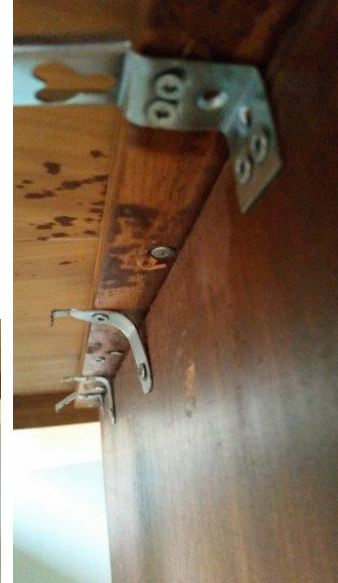
Photo 78 - Multiple Patches on Table Legs

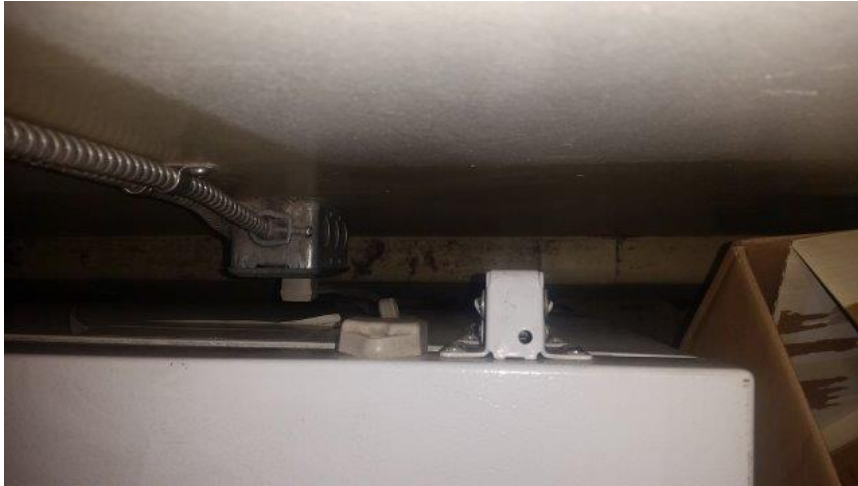
An infrared scan with a FLIR thermal imaging camera indicates relatively even heat distribution along exposed heat radiators. However, there are many objects in front of some heat radiators, which block heat transfer into the main room of the hall.

Photo 84 – Looking Down on Deep Freeze Blocking Hot Water Heating in Janitorial Storage Room

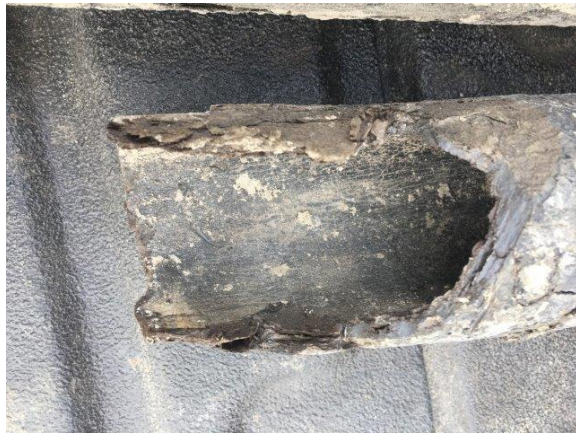
In 2020, the supply cables from the church to the hall short circuited along their underground path. The cables could not be pulled back to the church or to the hall to allow new cables to be pulled in. Subsequent investigation of the church drainage system showed that these cables were installed in steel conduit as they left the church boiler room wall, in No-Corrode or Orangeburg Root-Proof pipe (a form of cardboard and tar derivative (bituminized) pipe used for direct burial sewer service). It was developed to expedite post WWII housing construction and resulted in several hundreds of thousands of miles of pipe failure in sewer service.

Photo 87 - No-Corrode Sewer Pipe Used for Electrical Cables from Church

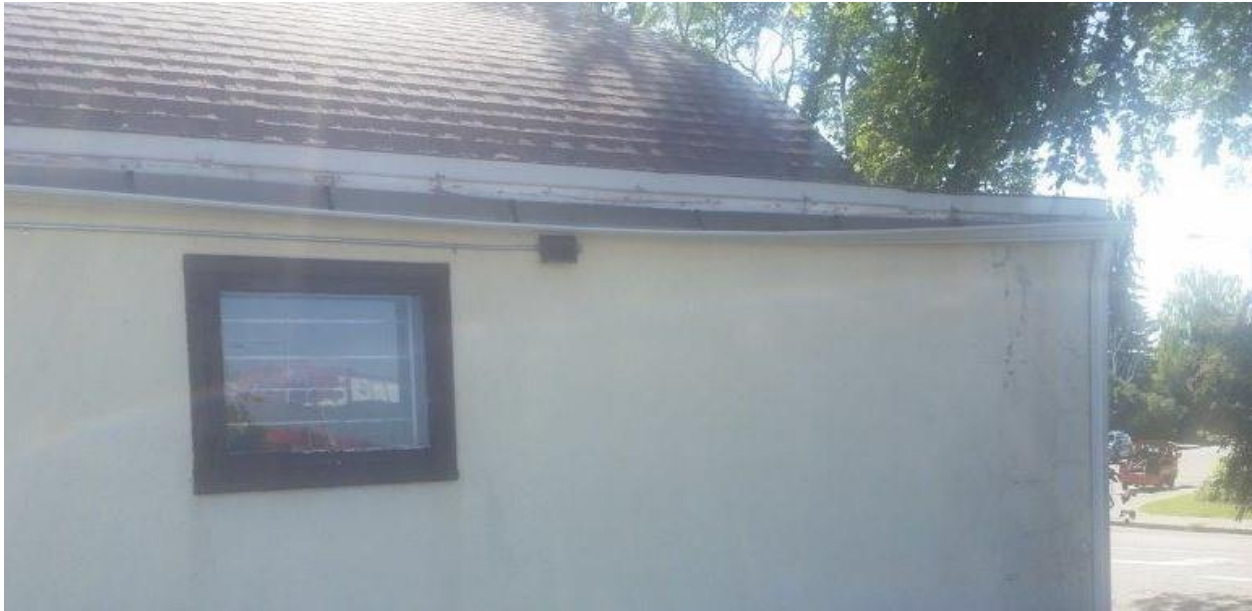
Eaves troughs drain adjacent to foundation. The low levels of roof insulation cause snow to melt from the roof, run into the eaves trough and freeze. The weight of the ice filled eaves trough cause the eaves trough to pull loose from the building. [See section 5.6]

Photo 95 - Eaves trough Damage from Ice Filling Eaves Trough
