St Pius X Hall

2424 – 24 Ave NW, Calgary AB

Functional and Physical Condition Assessment

March 16, 2022

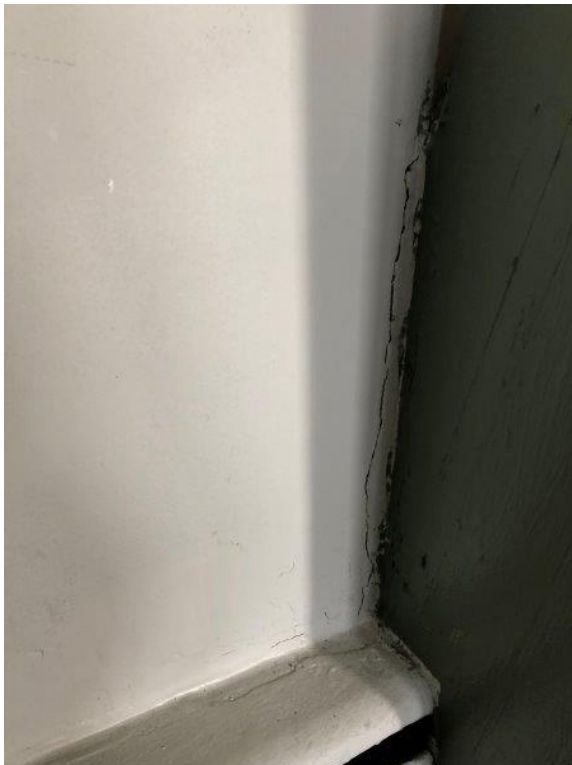
The roof framing (arches) is mostly exposed throughout the hall area and were examined at a few locations. Members were typically painted and were found to exhibit minor cracking (checking) at laminations (photo) but no obvious signs of distress were apparent. The connection of the arches to the sill plate were mostly concealed by finishes and heating cabinets at the base of the exterior walls. The condition of the sill plate was partially visible at a few locations, however, and the painted finish was found to be cracked suggestive of possible water damage (Photo 8 and Photo 9).

Photo 8 - Arch to Interior Wall Seam Cracking

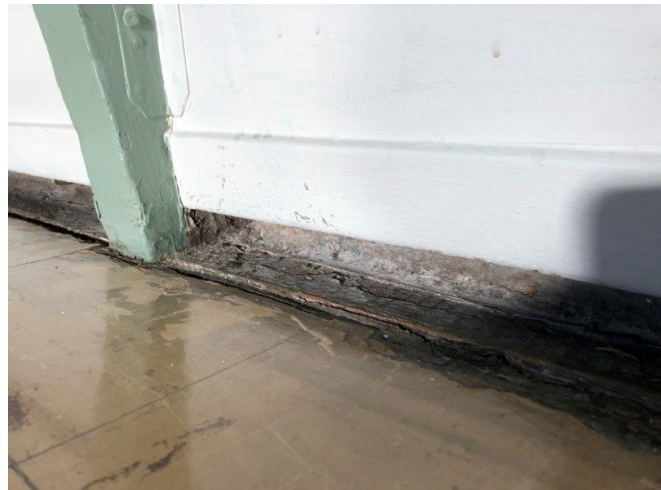
Photo 9 - Hall Interior Wall Showing Arch to Sill Plate Junction

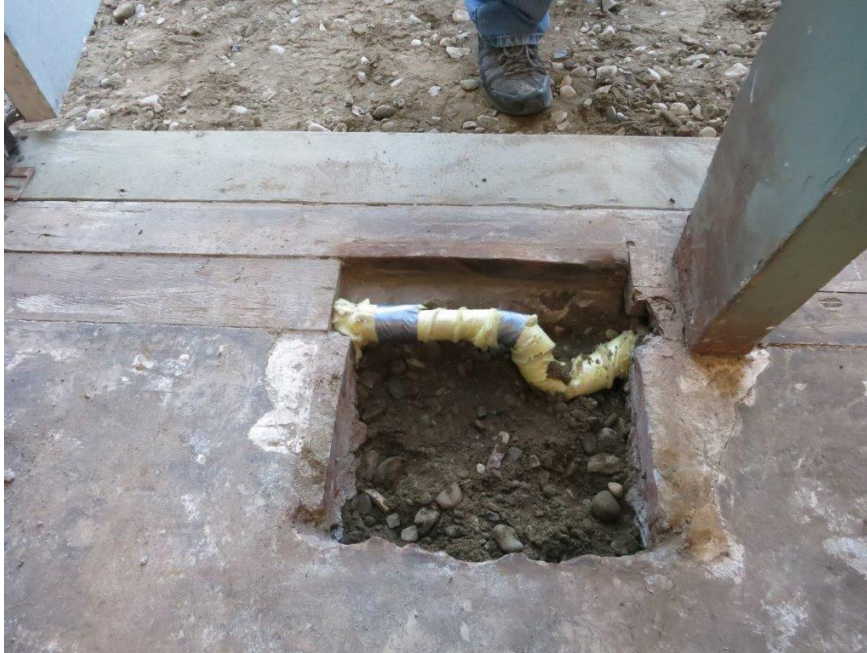
The hot water uninsulated heating pipes run under the floor slab in the vicinity of the arch rib connection to the concrete floor slab. The pipes almost certainly run inside the foundation wall since there is no logical scenario where a structural engineer would permit a bearing wall to be supported on mechanical piping. We have no explanation for the pipe routing shown in Photo 10.

Photo 10 - Arch rib to edge of concrete slab on grade floor/foundation. (Note pipe has been insulated in this one location only)

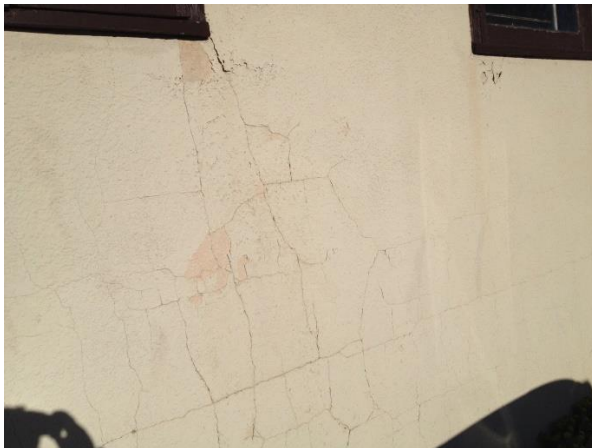
There are significant cracks and breaks in the exterior stucco walls. Many patches have been applied to the stucco for new doors, window repairs, etc. The multiple layers of paint on the stucco walls are peeling quite badly with many places where there is no paint remaining on portions of the stucco.

Photo 11 - Exterior of the Hall – Paint layer over stucco is falling off and cracks are forming in stucco

The exterior paint on the stucco was tested and found to contain lead.

- Cracks in existing stucco will show through any type of coating since the coating is very thin relative to the total thickness of existing stucco. No coating will cover the stucco cracks for very long. If the exterior stucco is to be repaired, the addition of a “fog coat of cementitious paint” is the recommended coating after all multi layers of paint have been removed. Color can be added to the coating mix.

- Application of an acrylic coating or latex paints will prevent the stucco from breathing, resulting in moisture accumulation within the wall cavity and application of such coatings that will seal moisture into the wall cavity is not recommended.

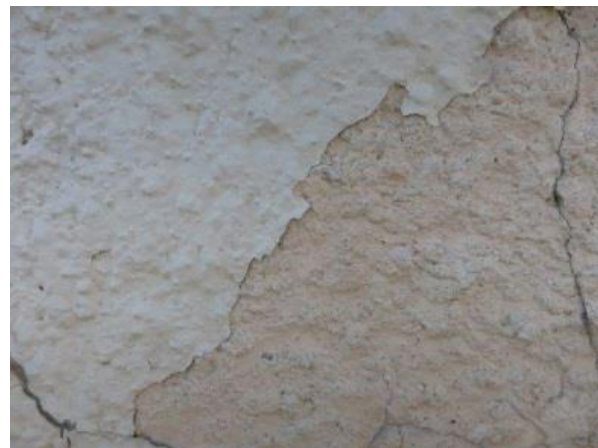
Photo 12 - Peeling Paint and Cracks in Underlying Stucco

The paint layer over the stucco is falling off and cracks are forming in stucco.

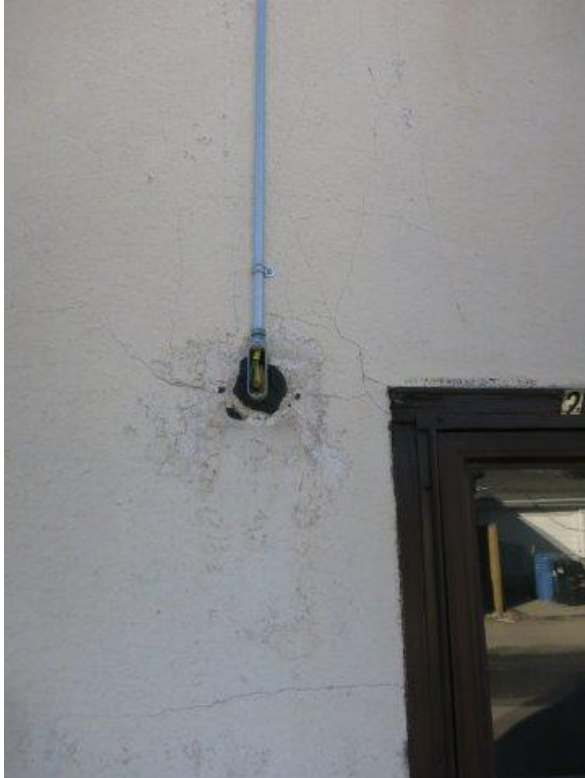
Blanked openings for electrical wiring fixtures and other devices are not sealed against water entry. Such instances are found on all walls.

Photo 13 - Open Electrical Conduit Penetration through the Stucco Wall

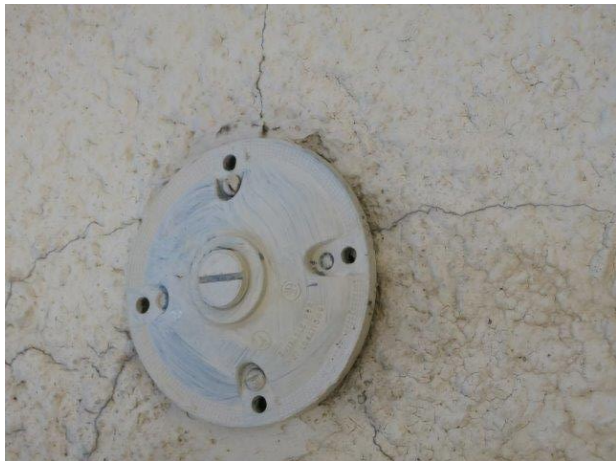
Photo 16 - Improperly Covered and Sealed Electrical Fittings

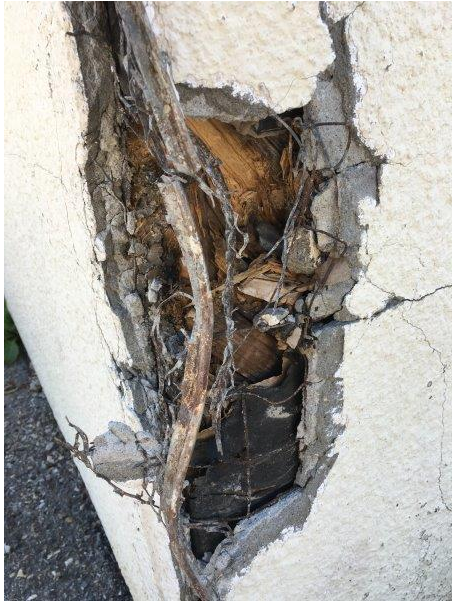
A part of the west and north walls is now below grade. Damaged stucco has allowed wall framing, plaster lath and the interior wall to be exposed to the outside and to surface ground and rain water.

Such damage provides a potential ingress location for mice as well as water to further damage the corners of the building.

Photo 17 - Damage to Corner of Hall Interior Wall Wood Exposed to Water

Correction of this issue will require lowering the ground and asphalt surfaces, implementing drainage in this area and re-contouring of the pavement at the north end of the hall. Only then could the interior wall damage be corrected. Drainage along the entire west wall is an issue and is not consistent with positive drainage of runoff away from the building (see section 12 for additional comments pertaining to site grading issues).

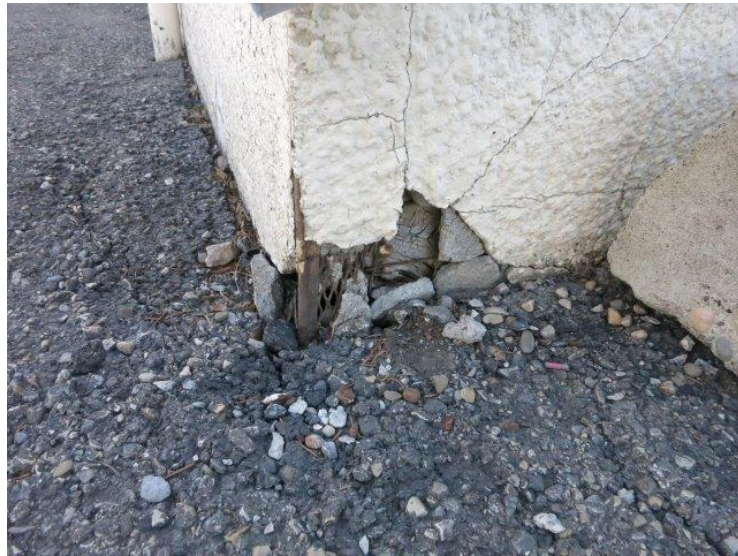
Photo 18 - Damage to Hall Corner. Note Wall is Below Surface at this Location

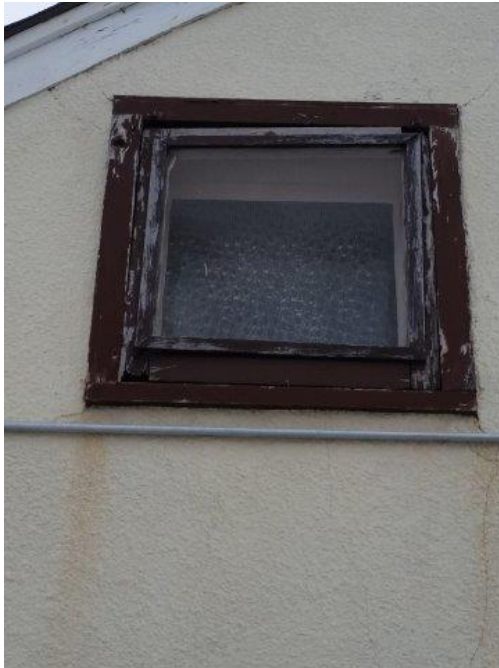
Doors and windows and their associated framing on the north end of the hall have rotted. The wall studs are visible in several rot openings.

Photo 19 - Window in North wall of Upper Bedroom (now office) with Rotted Frame

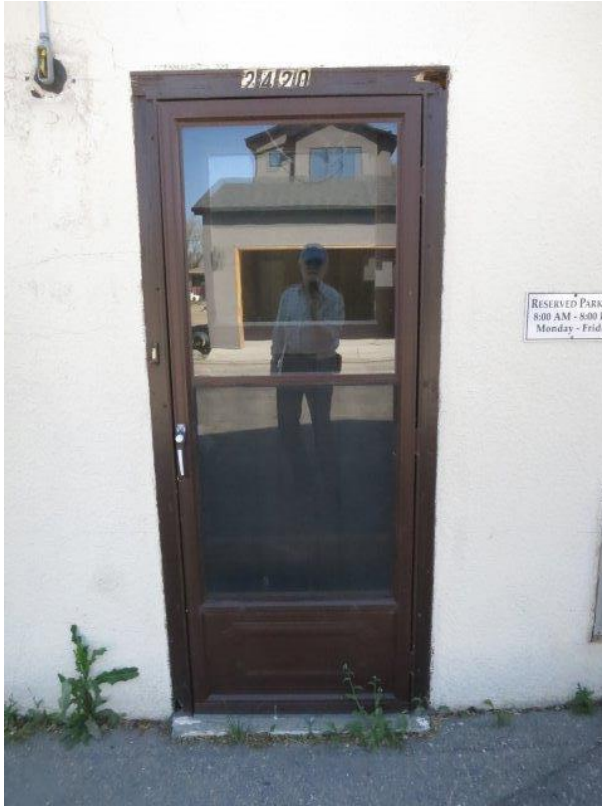
Photo 21 - North End door With very Rotted Frame

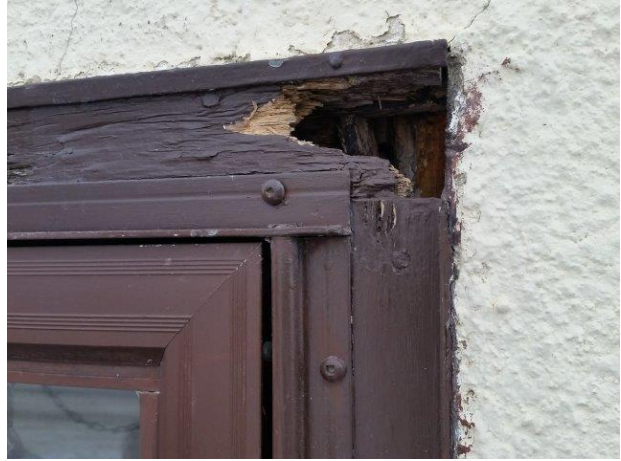
Photo 22 - North Door Frame Rot

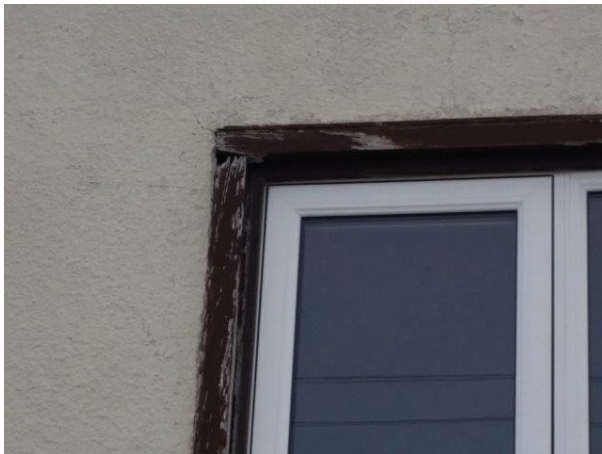
Photo 23 - Rotted Frames around Replacement Thermopane Sealed Window Units

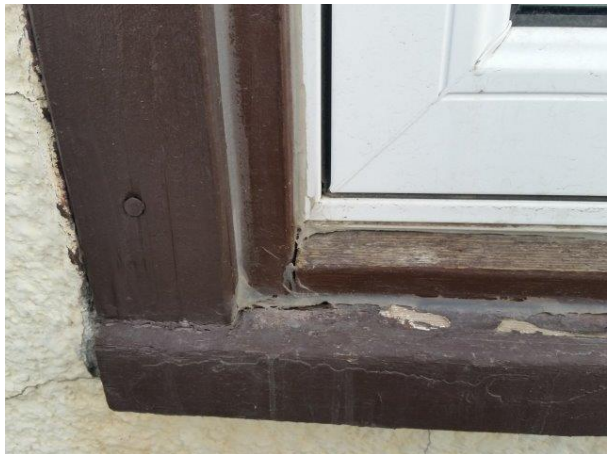
Photo 24 - Rotted Frames around Replacement Sealed Window Units

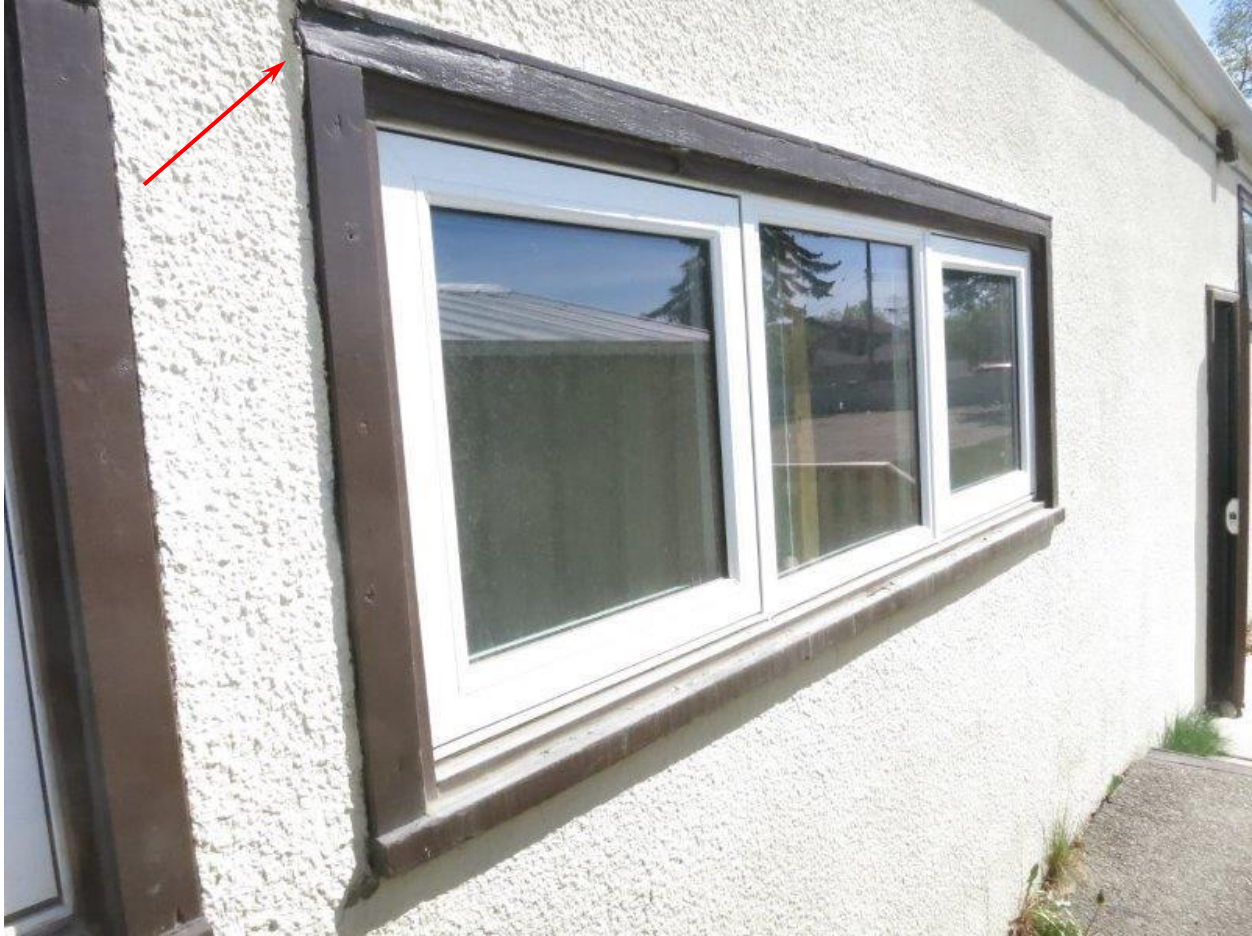
Photo 25 - New Sealed Double Glazed Windows set into Original Frames that are now Rotting. Note how this West Wall of the Hall is Buried Under the Asphalt

A few years ago, the windows on the west side of the hall (in the kitchen area) were replaced with sealed thermal pane double glazed windows set into the original wood frames. This was likely done to avoid having to perform stucco repairs when the expected life of the hall was unknown. Over the years since then, the wood frames around the new window units have rotted.

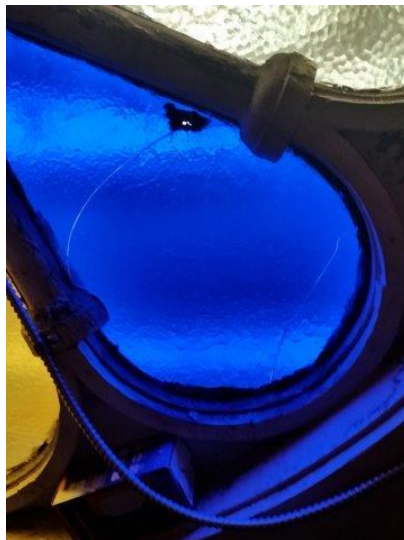
Photo 27 - Broken Single-Pane glass in Circular Window

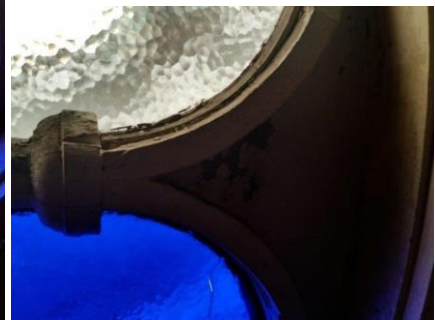
Photo 28 - Rotted Wood in Hand Built Stained Glass Window

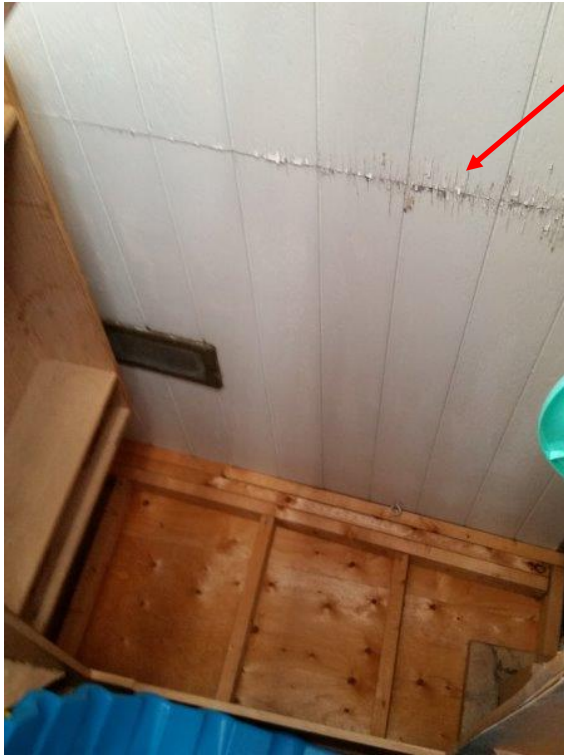
Photo 31 - Leaking Roof in Church Original Entrance Vestibule

The vestibule has a flat roof that now leaks.

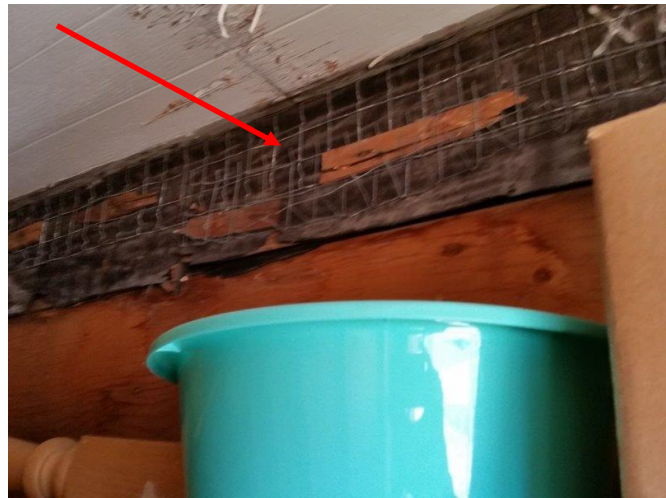
Photo 32 - Unfinished Exterior Wall Where Original Entrance Vestibule was Located

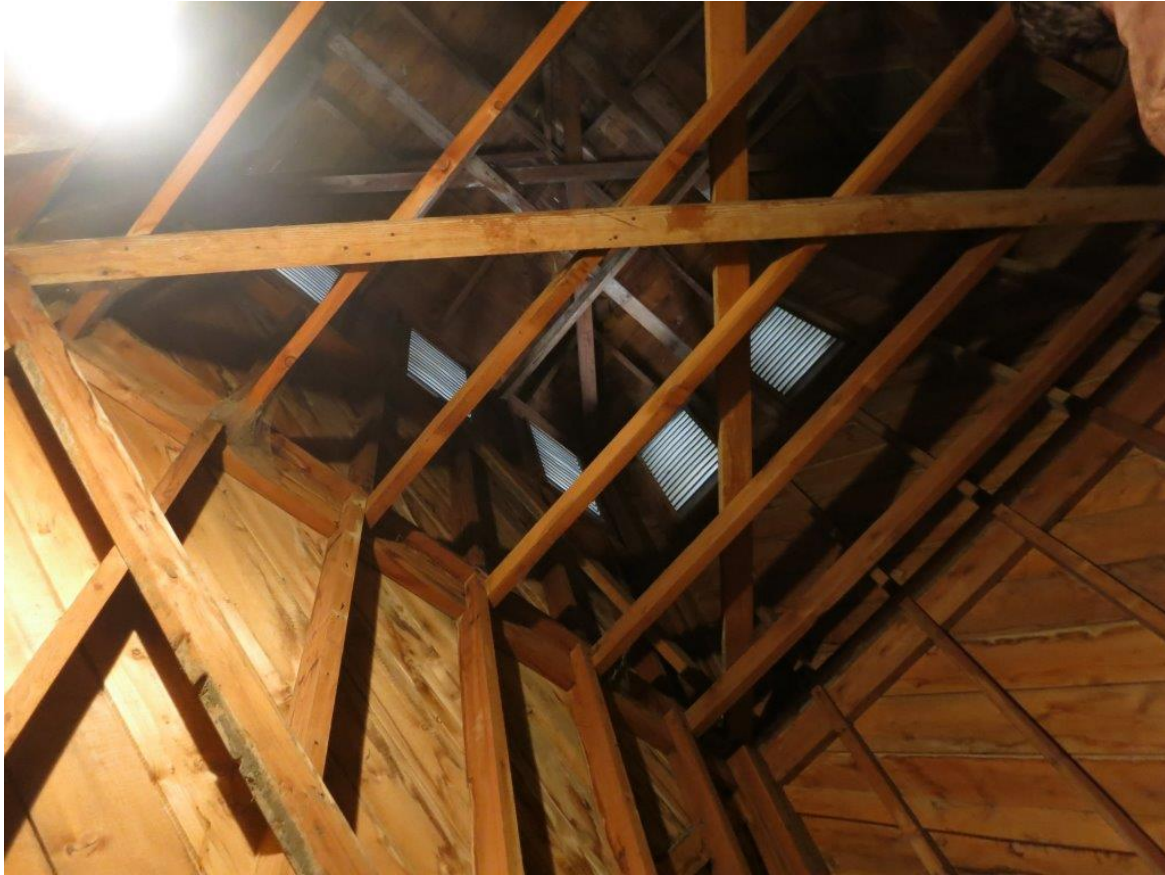
Bell tower “window” framing is either blanked (with rotten plywood) or screened (with torn or missing screening) allowing birds, bats and perhaps mice into tower cavity. The net result has been that there is some minor water damage to the walls and framing members, although some framing members are broken.

Photo 33 - Interior of Bell Tower

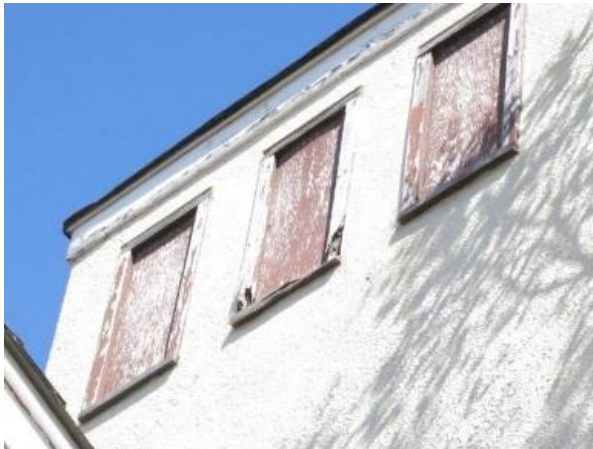
Openings are either blanked (with rotten plywood) or screened poorly (with torn or missing screening) allowing rain water, birds, bats and perhaps mice into tower cavity. There is some water damage to the framing members of the tower, with several broken.

Photo 40 - Blank Windows on Faux Bell Tower

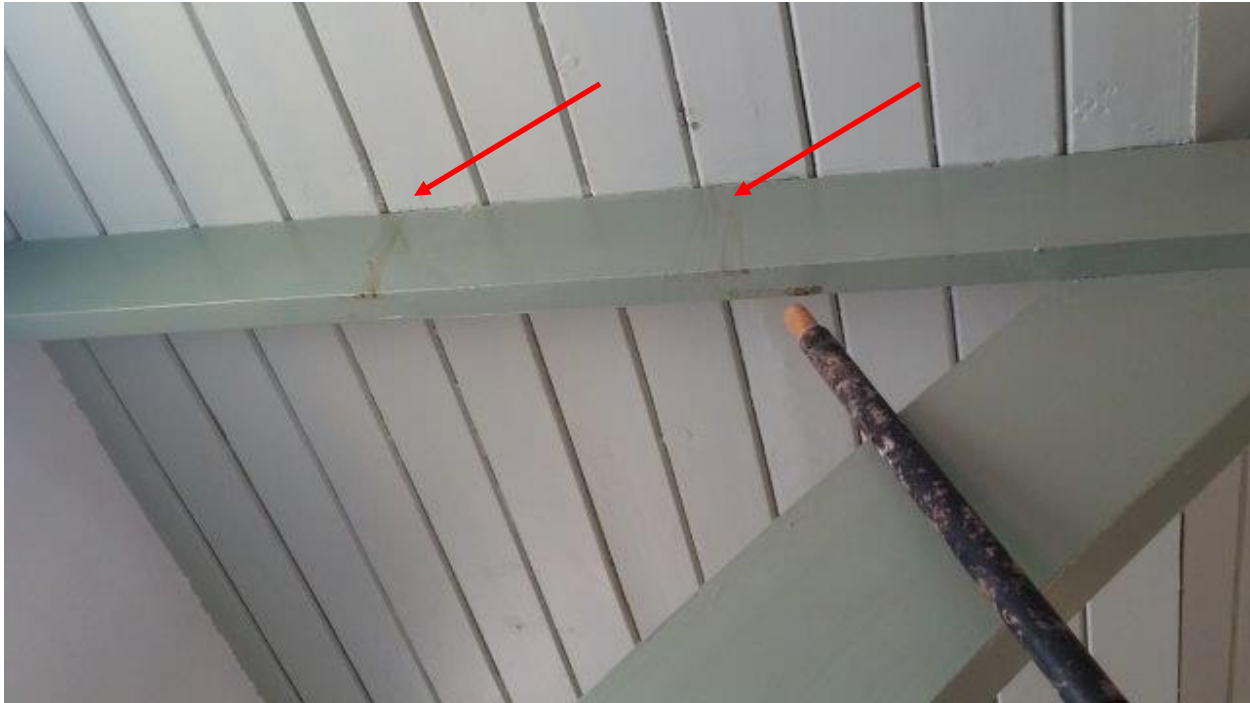
Photo 42 - Water Leakage on the Interior/Underside of the Roof

Leaks in the roof could be an indication of rot in roof planking.

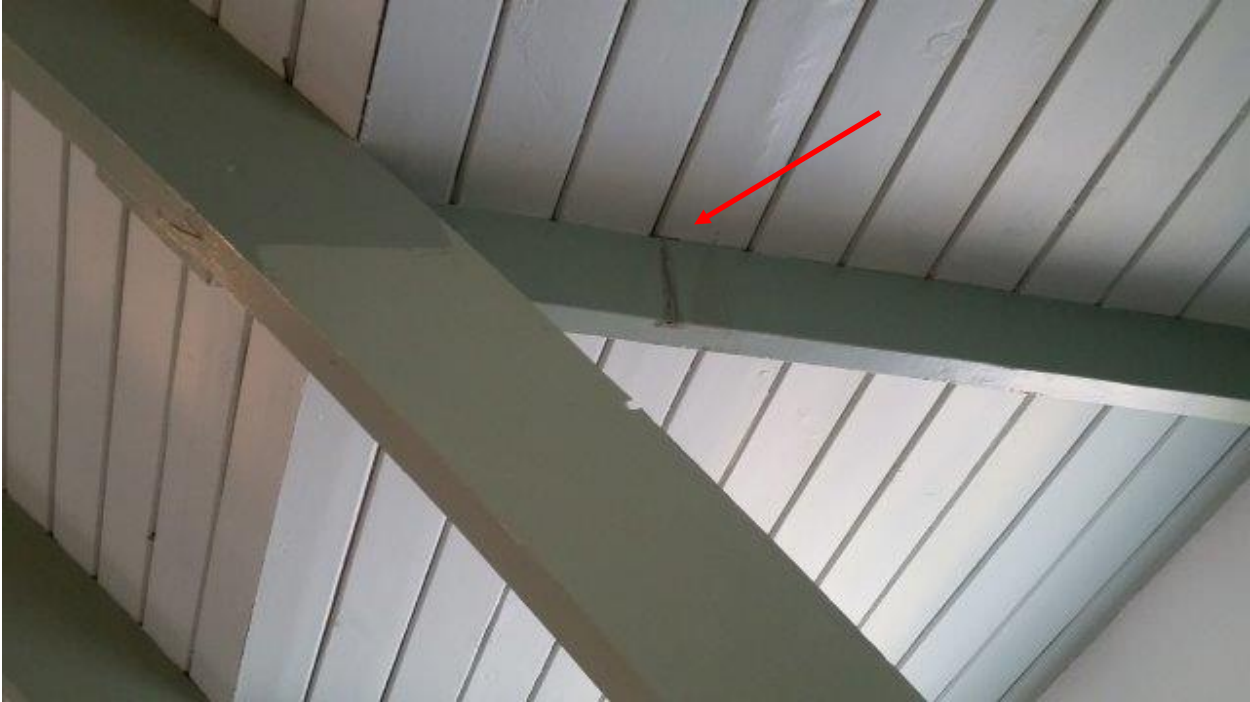
Photo 43 - Water Leakage on the Interior/Underside of the Roof

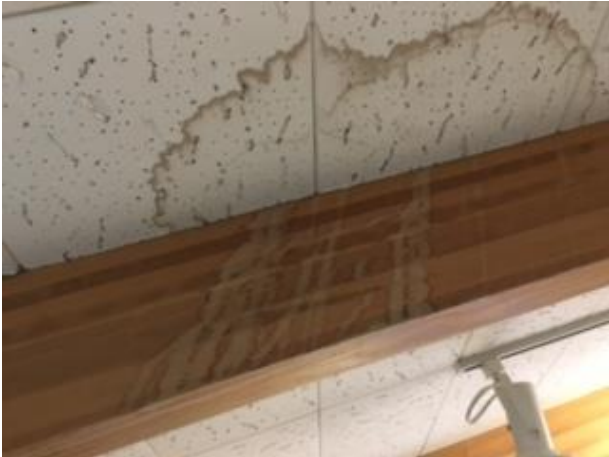
Water stains have been observed on the inner ceiling of the upstairs office. Leaks in roof could be an indication to expect some rot in the roof planking.

Photo 44 - Water Stains in Ceiling of Upstairs Office

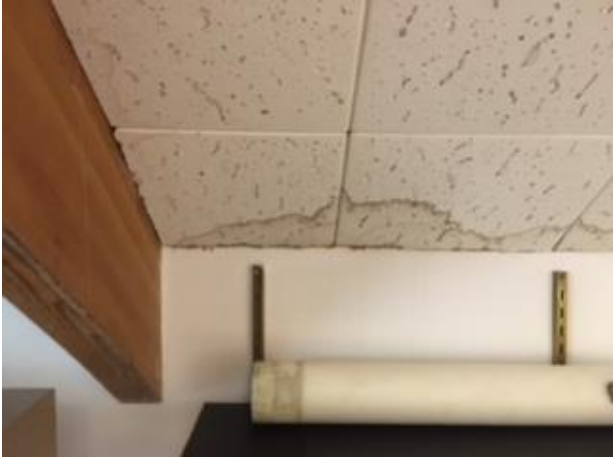
Photo 45 - Water Stains in Ceiling of Upstairs Office

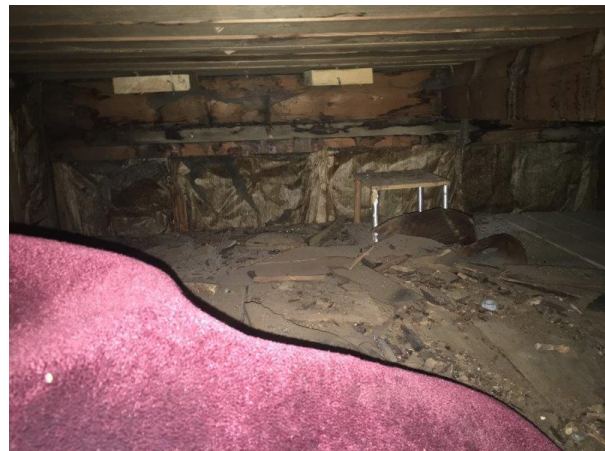
Water damage is evident on the underside of the flat portion of the roof deck.

Photo 48 - Top of West Wall (at back of photo); Underside of Flat Portion of Roof (at top of photo); Water Leakage and Re-Roofing Debris in Foreground

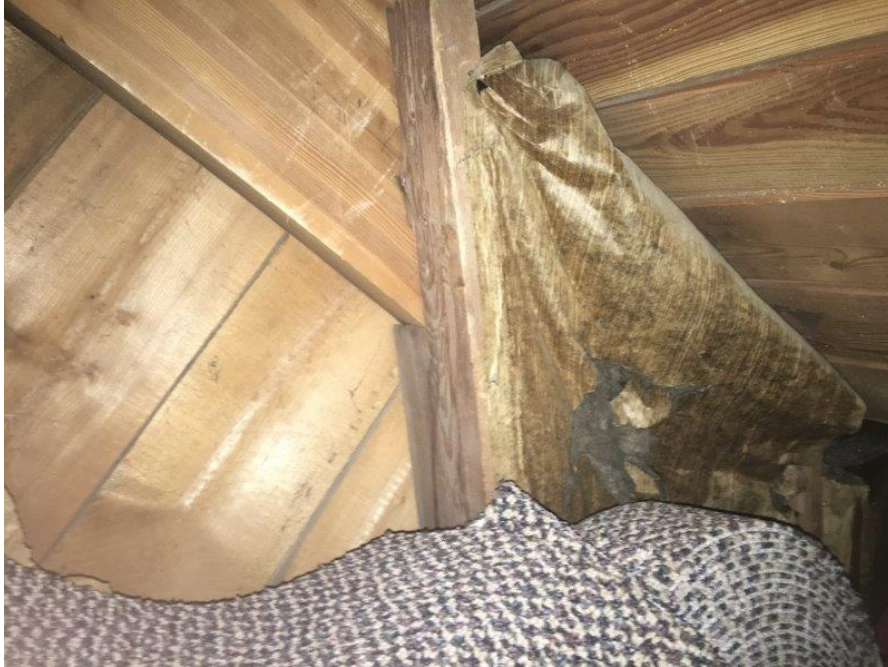
Photo 49 - South Wall Framing Composed of arch, Timber Framing and Diagonal Shiplap Lumber. Note Lack of Insulation on Portions of the Wall.

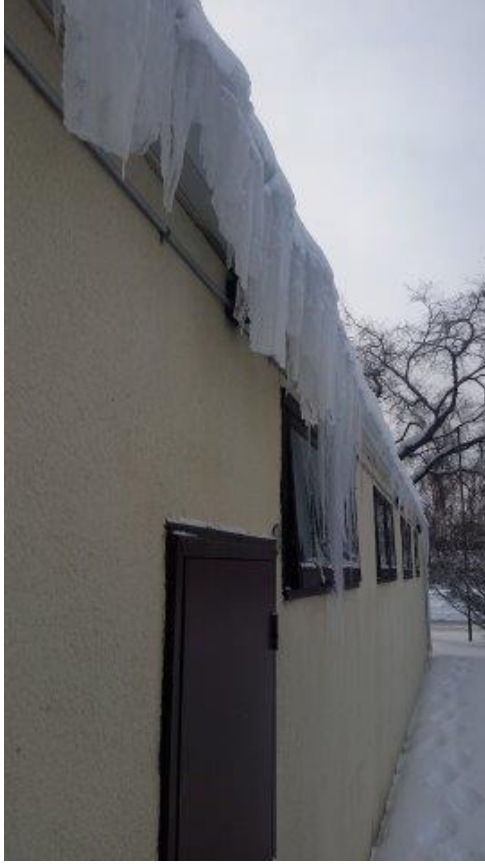
The eaves troughs and fascia have required persistent repairs due to stresses created by the roof design, and ice buildup resulting from the heat loss through the roof. This is a difficult problem to resolve.

Photo 50 - Icicles along West Wall of Hall

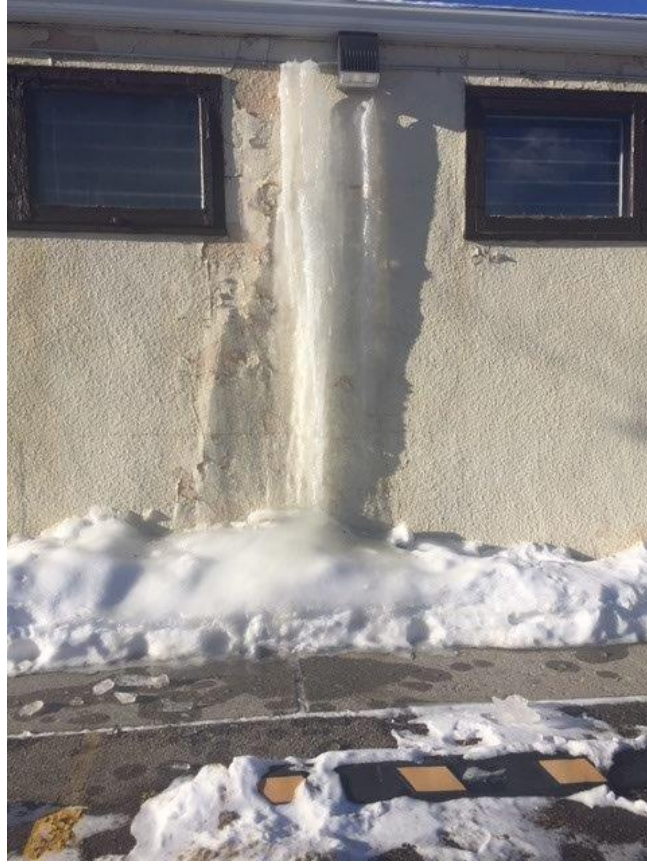
Photo 51 - Icicles along East Wall of Hall

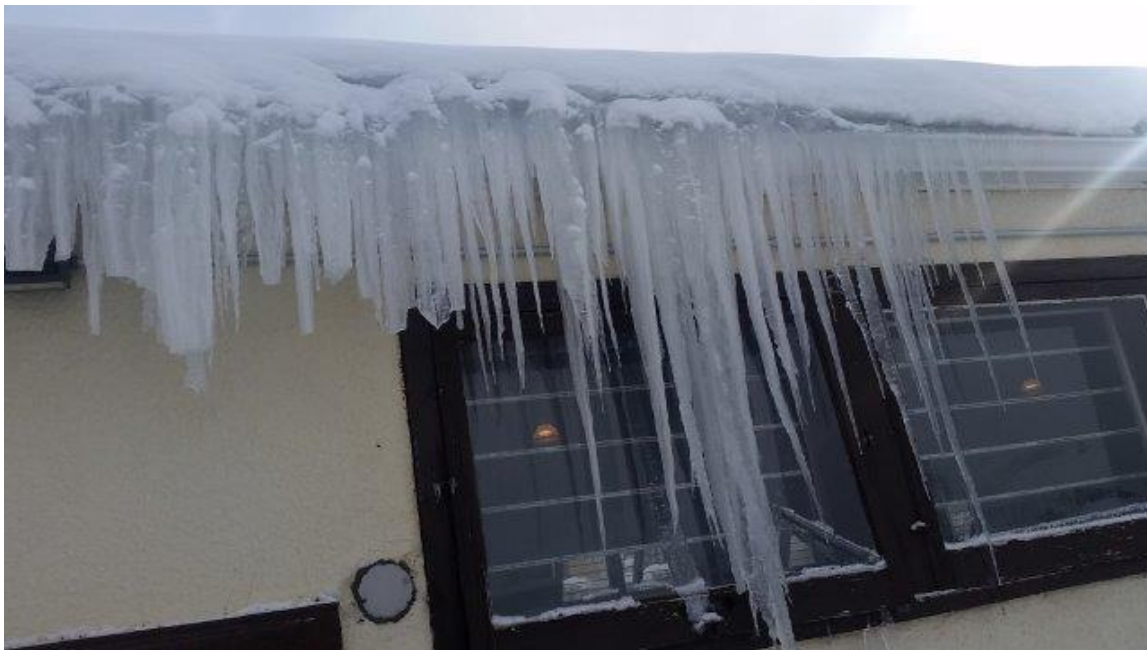
The minimal roof insulation results in significant thermal loss through the roof, causing snow to melt and fill the eaves trough, and then freeze causing eaves trough failure and risk of falling ice injuring someone. It has also caused water to start to leak through the roof to the building interior or to back up under the shingles and then through the interior planked deck of the roof. The roof leaks to the interior were observed at the time of recent interior painting. The leaks are generally at the junction of the curved and flat portions of the interior ceiling portion of the roof.

Photo 52 - Icicles along West Walls of Hall. Icicles from melted Snow on Poorly Insulated Roof

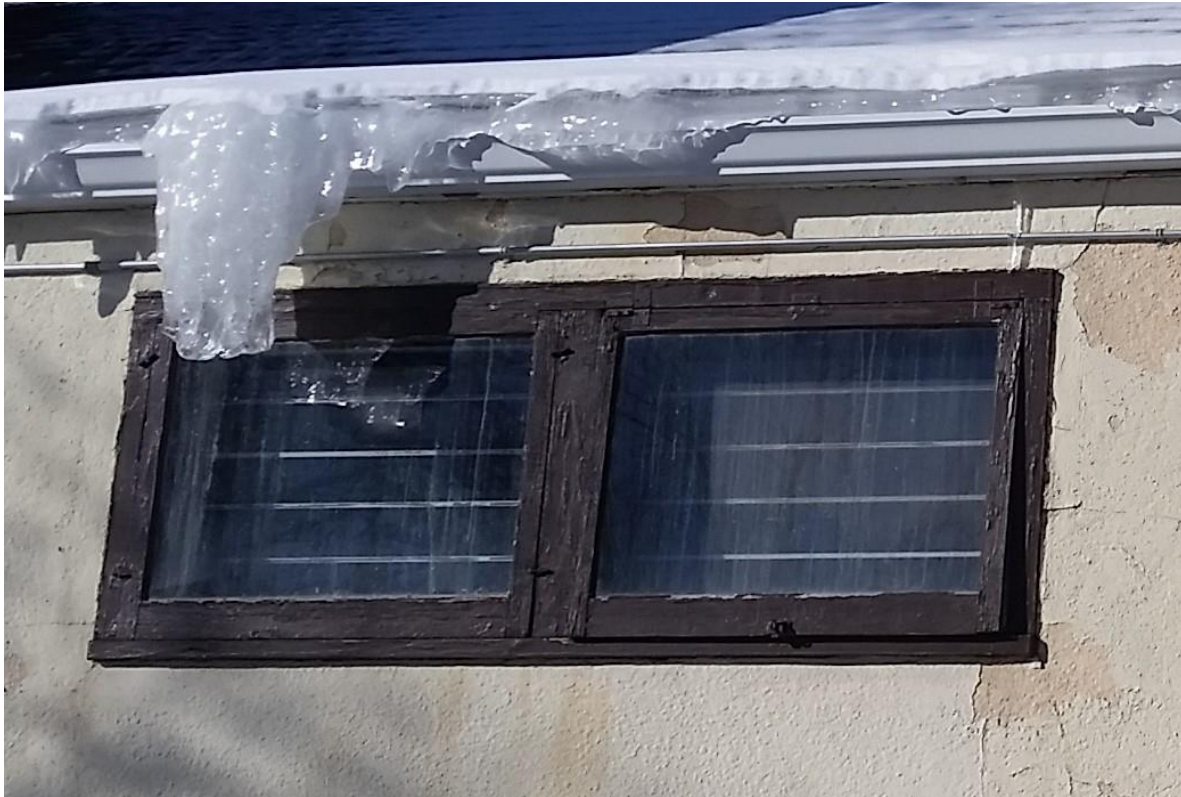
Photo 53 - Icicles along West Walls of Hall. Icicles from melted Snow on Poorly Insulated Roof. Note Window that will Not Close.

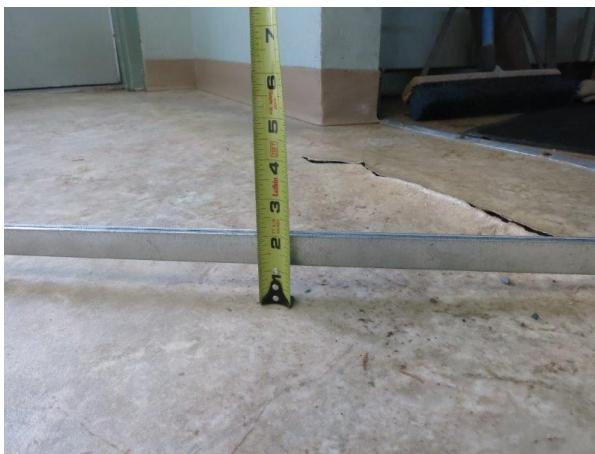
Photo 56 - Sagging floor at main entrance to hall

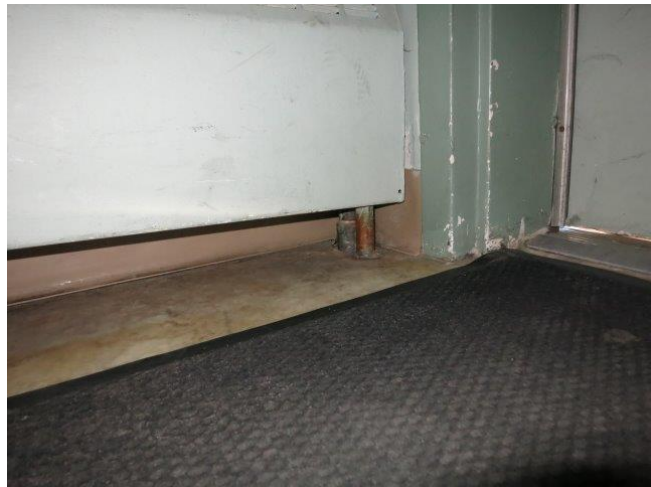
Photo 61 - Deteriorated Floor Covered with Matting; Note Light Under Left Edge of Door

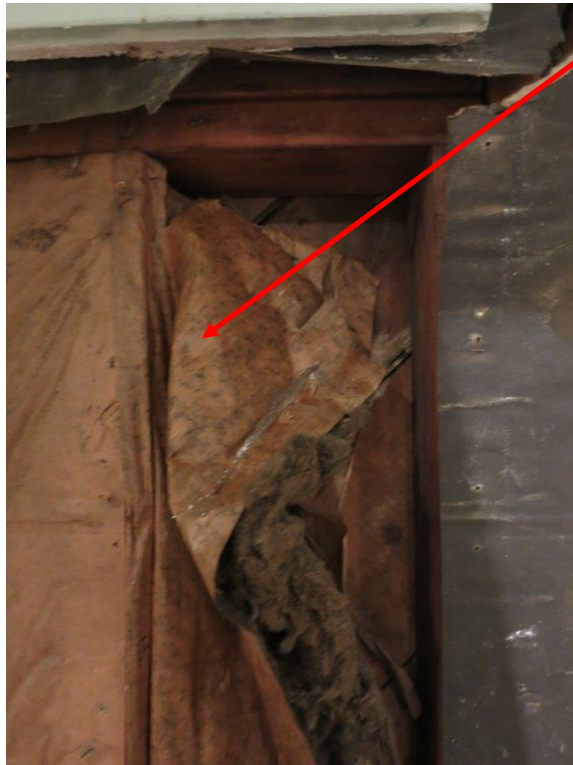
The insulation is approximately two (2) inches thick providing no more than R6 insulation; however, it has places, at least under the examined windows, where the insulation does not even completely cover the outside wall. The current building code requires R24 insulation for exterior walls.

Photo 62 - Wall Insulation that is Sagging, Unsupported and Incompletely Covering Wall

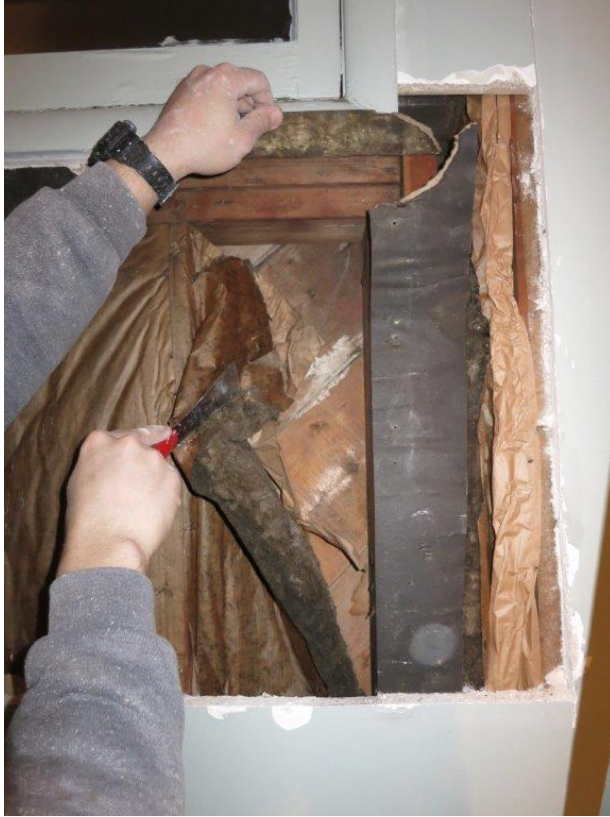
Photo 64 - Top right side of west wall under window. Minor damage on outside wood sheathing. Very incomplete vapour barrier. Tar paper over double framing members.

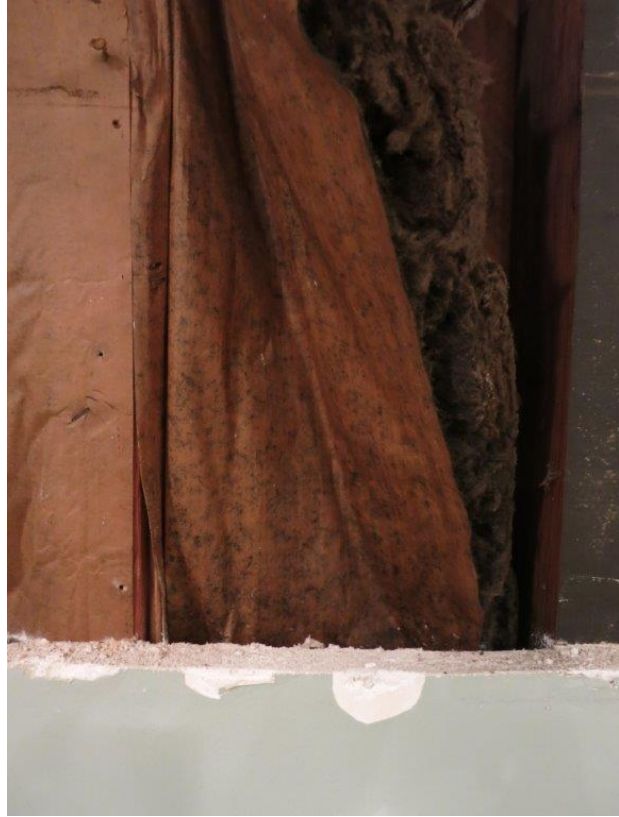
Photo 65 - Mould on Paper-Backed Insulation in Wall Cavity

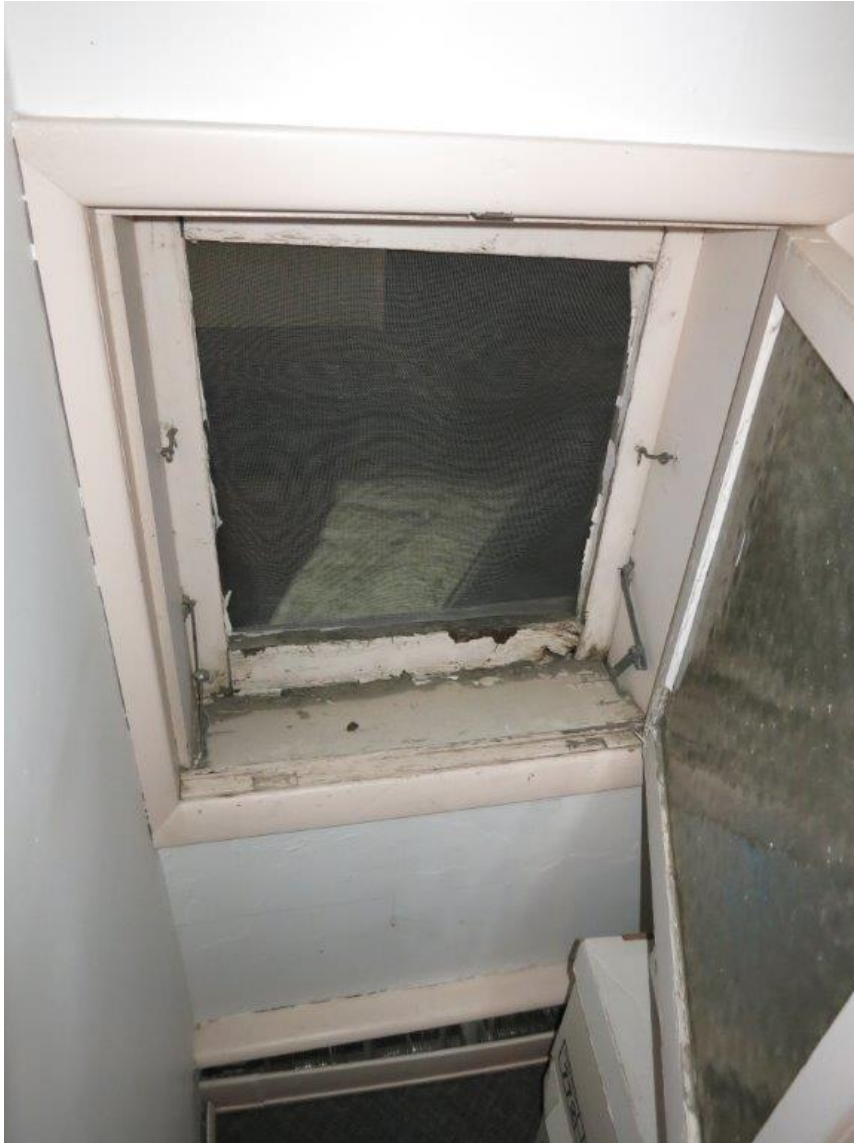
We observed that the window in the upstairs office is in quite a deteriorated condition, especially on the outside. The wallboard under the window appears to be in fair condition, especially considering the condition of the outside window frame [See Photo 19]. The outer screen and the window brick mould/trim are in dire need of replacement.

Photo 76 - Upper Office Original Window

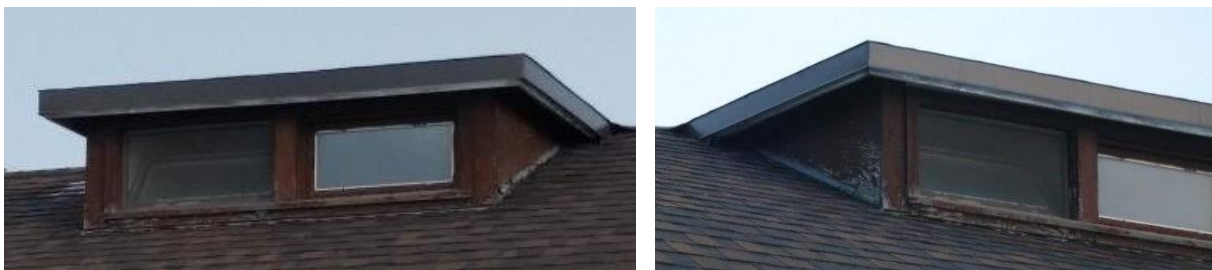
The upper office has a double “look-out” window providing light to the original bedroom and stair areas. This window is also showing considerable signs of deterioration.

Photo 77 - Upper office "Look-out" Window

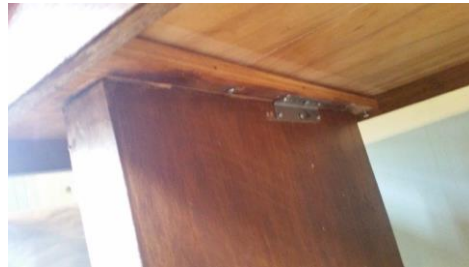
Photo 85 - Repairs to Table Legs

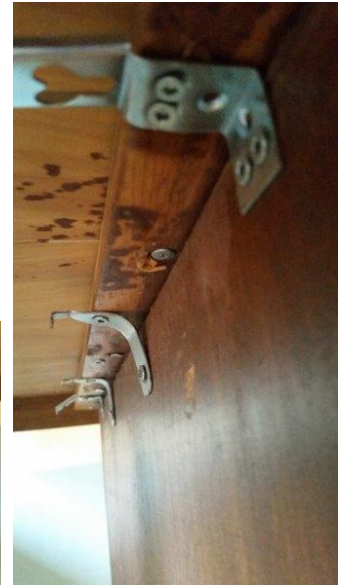
Photo 86 - Multiple Patches on Table Legs

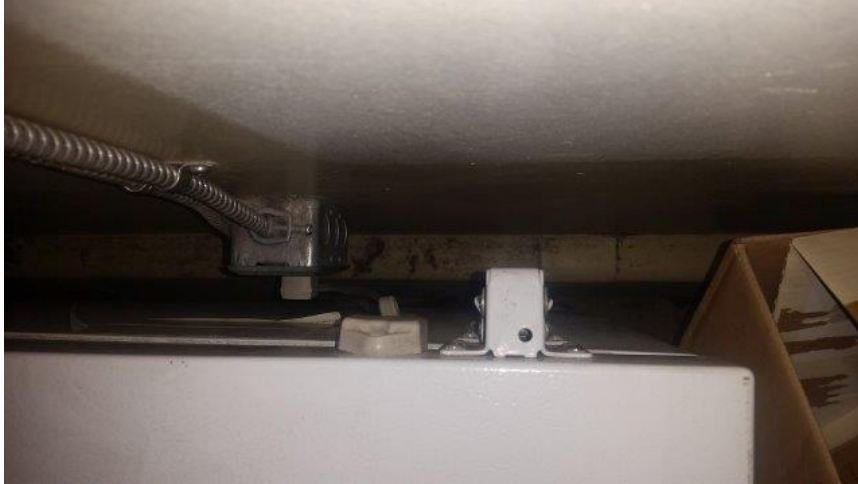
An infrared scan with a FLIR thermal imaging camera indicates relatively even heat distribution along exposed heat radiators. However, there are many objects in front of some heat radiators, which block heat transfer into the main room of the hall.

Photo 96 – Looking Down on Deep Freeze Blocking Hot Water Heating in Janitorial Storage Room

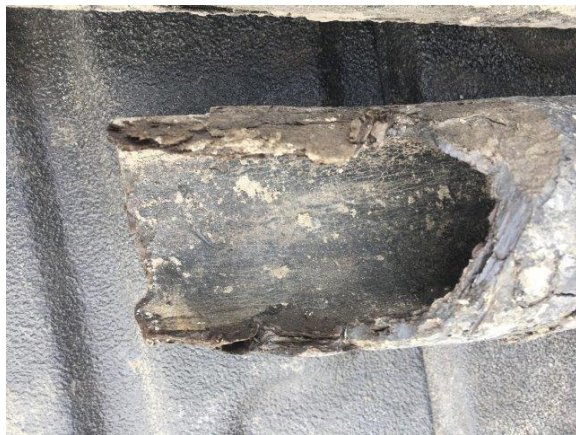
Photo 99 - No-Corrode Sewer Pipe Used for Electrical Cables from Church

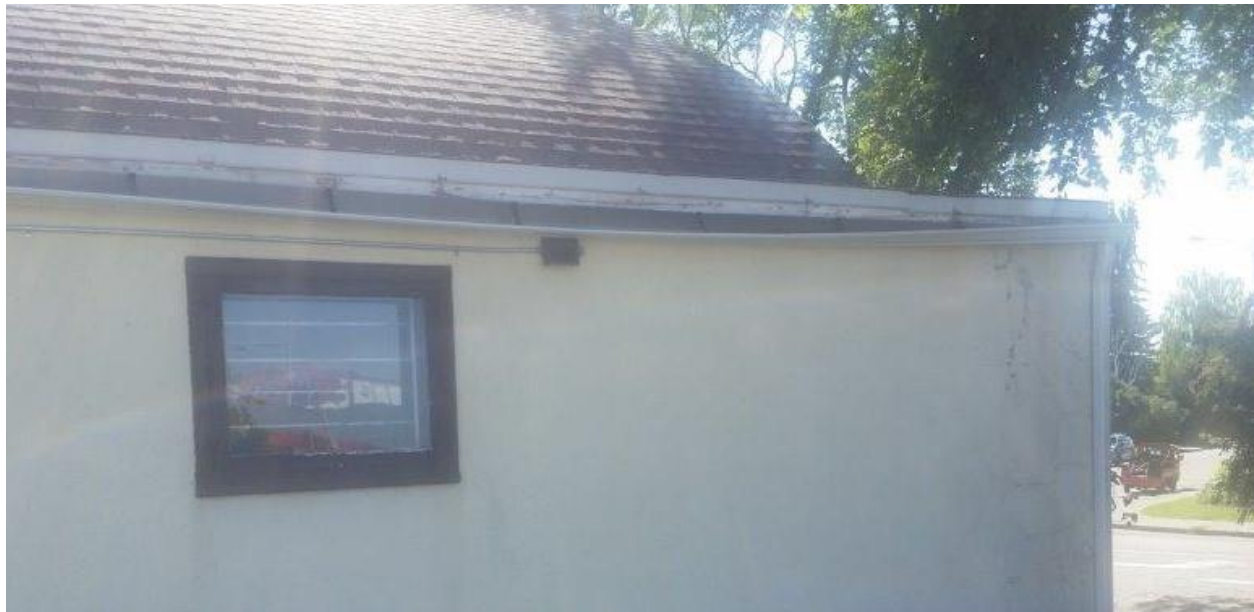
Photo 107 - Eaves Trough Damage from Ice Filling Eaves Trough
