St Pius X Hall
Functional and Physical Condition Assessment
by
St Pius X Building & Maintenance Committee

This report is intended to provide an overview of the general condition of the parish hall for the purpose of providing Parish Council with information necessary to inform their decisions on future plans for the hall. The facility assessment was undertaken by the parish Building Maintenance Committee (BMC) comprised of individuals having professional experience in relevant engineering disciplines but is not intended to replace a detailed engineering investigation of the facility and component systems.

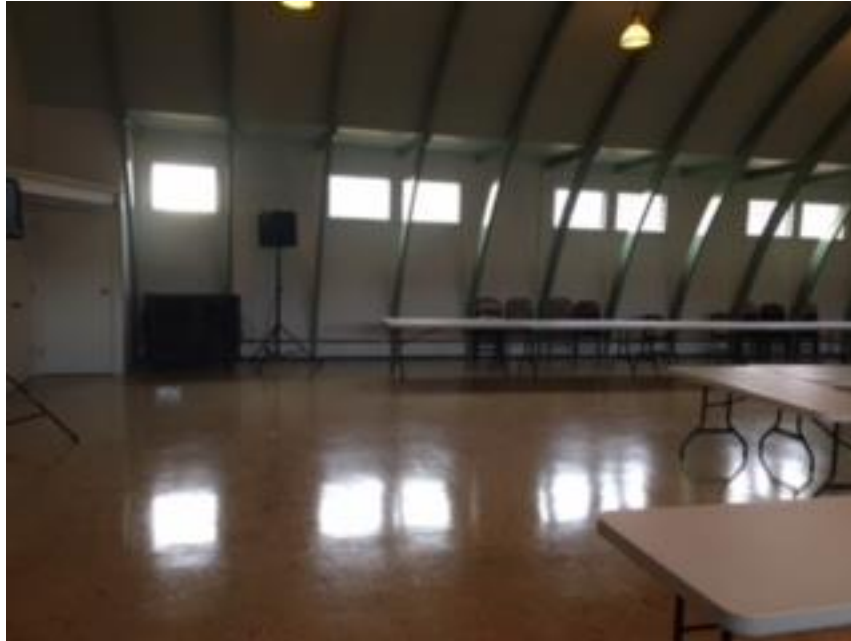
The hall footprint occupies a 40'-6 x 86'-0 foot (12.34 x 26.21 m) area for a total building footprint of 3483 square feet (323.58 m²). However, much of this area is taken up by an office, a kitchen, washrooms, storage areas for the main hall, and intrusion of the arch ribs along each side of the main hall by approximately 3 feet.

Photo 7 - Arch Rib Construction along the Straight Walls Intrude into Main Hall Space

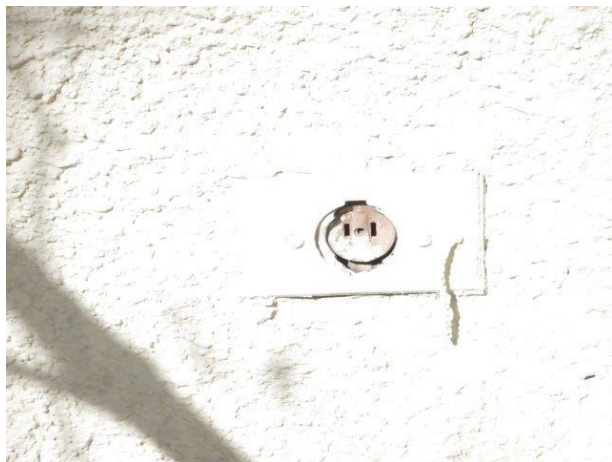
Photo 13 - Unsealed, (and Non Grounded) Electrical Receptacle

The building exterior receptacles use a two wire system (hot and neutral) with no ground and no GFCI protection [Refer to Photo 13]. This type of electrical system was the norm in the 1950s.

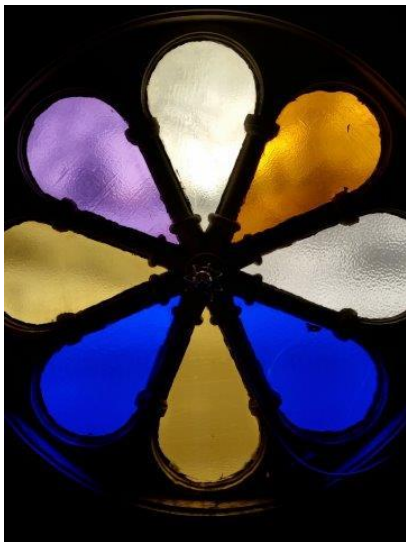
A hand built stained glass circular window above the original church entrance and a feature visible from 24 Ave NW is unfortunately broken, rotting and allowing rain and cold air to enter the hall. It has single pane glass with some panes broken. It is lighted at night by means of a special bulb and a timer.

Photo 24 - Stained Glass Front Window

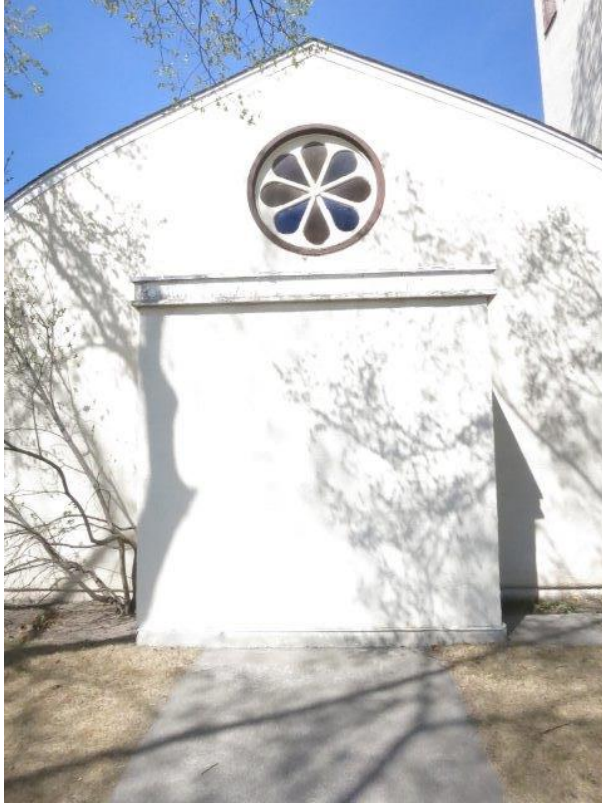
The original hall had an enclosed vestibule type entrance surrounding the front interior entrance door to the hall. At some time, the interior door was sealed off from the outside; however, the inside of the vestibule was never finished on its inside.

Photo 27 - South (Original Main) Entrance to Hall (Now Closed Off)

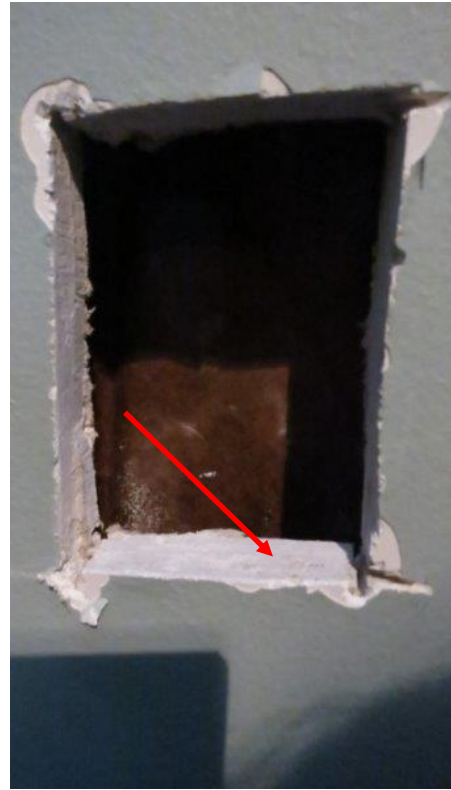
Photo 47 - Hole on Inside Hall Wall where Sample was Taken for Hazardous Material Sampling. Note line between Hardboard and Drywall Materials

The wall cavity was found to contain moderate to low levels of mould in the paper-backed insulation and wall cavity. Informally, the lab associate these levels with a relatively high air flow through the wall, maintaining a dry wall cavity. The wall does have a relatively high leakage rate compared with a building constructed in the present era. [Refer to Appendix 33]

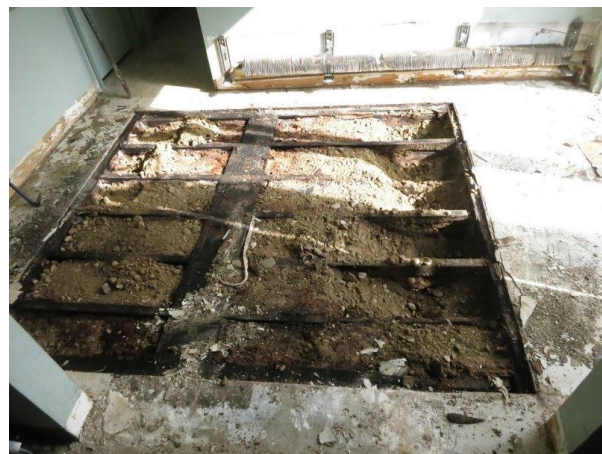
Photo 49 - Rotted Framing Below Main Entrance Floor

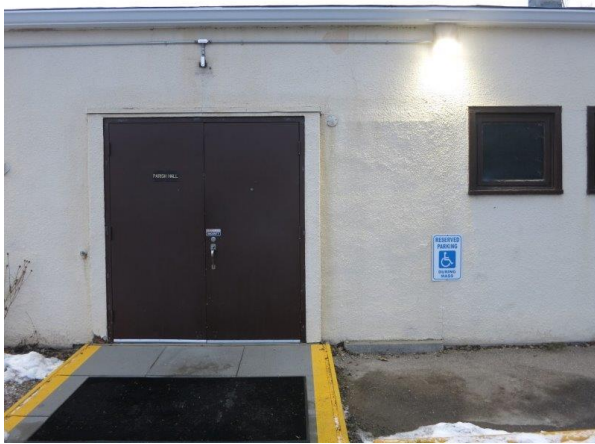
Photo 50 - Sloped Ramp added to Main Entrance 2016

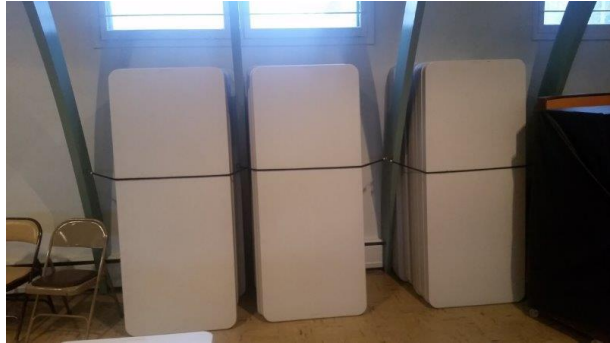
Photo 60 - Tables Stacked Against the Wall in Somewhat Precarious Arrangement

Note that some shelving units are not attached to the walls and could be pulled down accidentally. The tables are not well secured in their “storage positions”; however they are held in position with small bungee cords

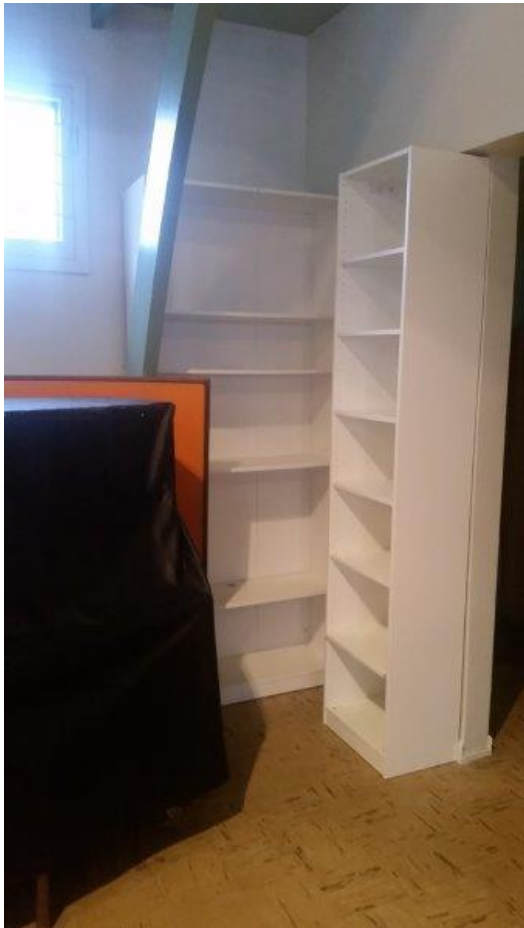
Photo 61 - Combination of Shelving between Arch Ribs and Free Standing.

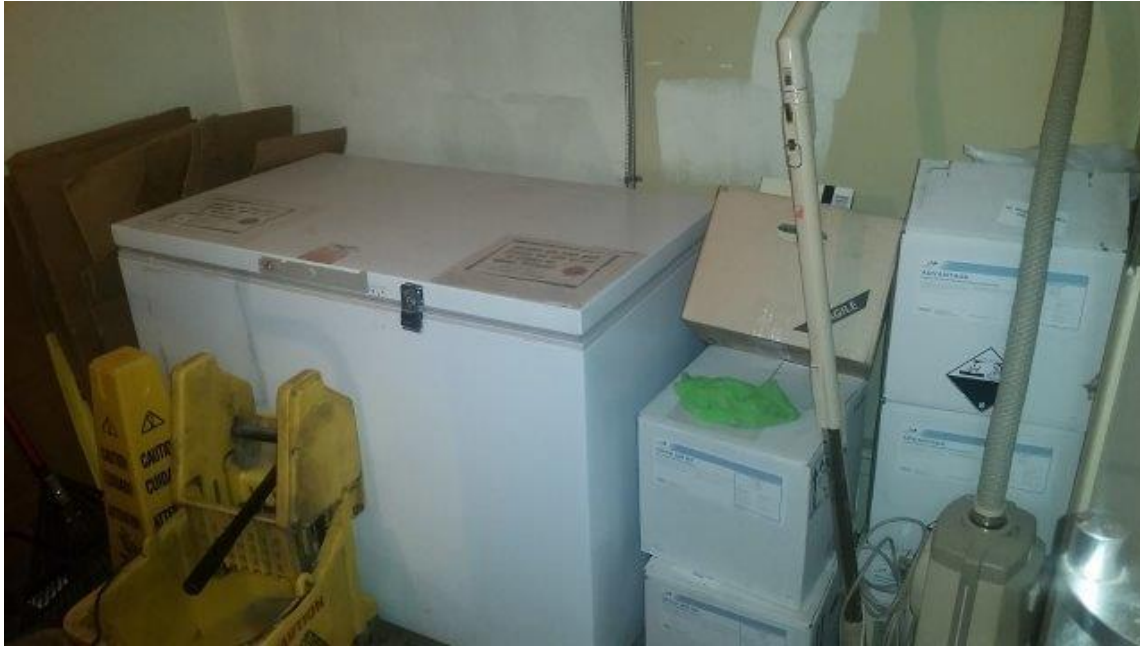
It does not have a water supply or large sink to assist with mopping up spills or floor washing. Users have to obtain water from the kitchen which is not set up for filling mop pails, etc.

Photo 66 - Storage in the "Janitorial Room" of Paper Files, Food Freezer and Cleaning Supplies

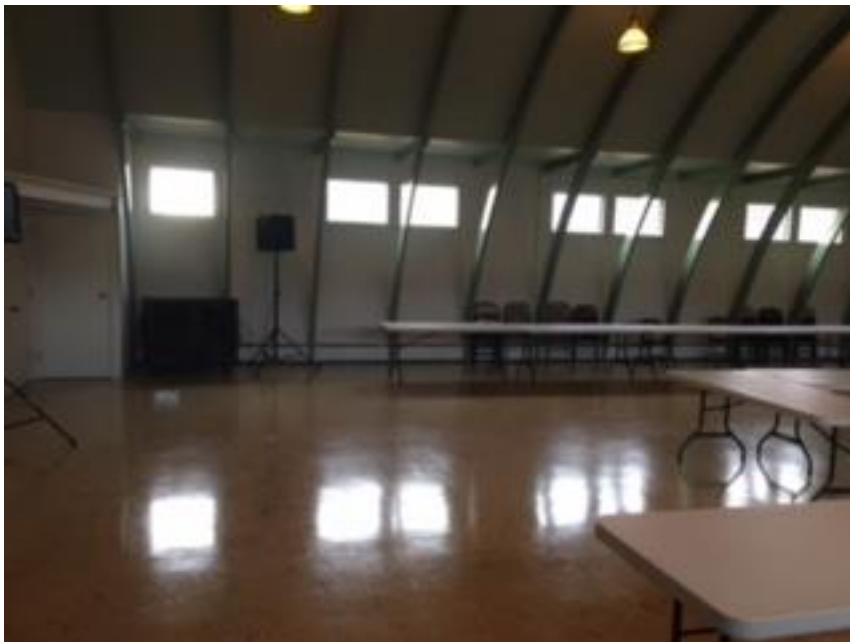
Photo 70 - West side Wall of Main Hall showing Arch Ribs, Windows, and Relocatable Stacking Tables and Chairs

- just above the main hall side windows or the flatter portion of the main hall above the windows, or
- at the same height as the floor in the upstairs office. [See Photo 70]

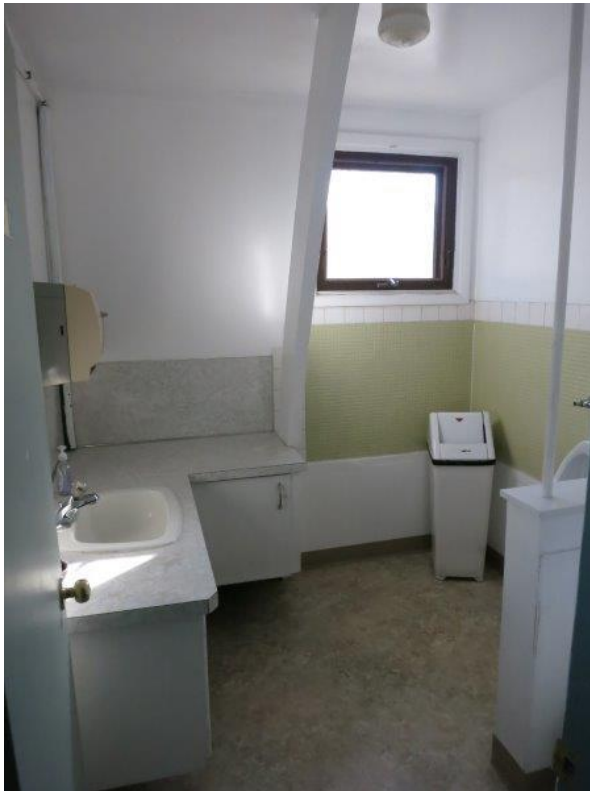
Neither washroom meets accessibility standards or requirement of today [Nor do the washrooms in the church meet accessibility requirement of today].

Photo 71 - Men's Washroom is Former Rectory Main Level Washroom. Tub was where Garbage Can is in Photo

These washrooms were never constructed with today's accessibility goals. To achieve accessibility goals, the washrooms would require complete rebuilding and a considerably larger footprint. In addition, access to both washrooms is via quite a narrow hallway.

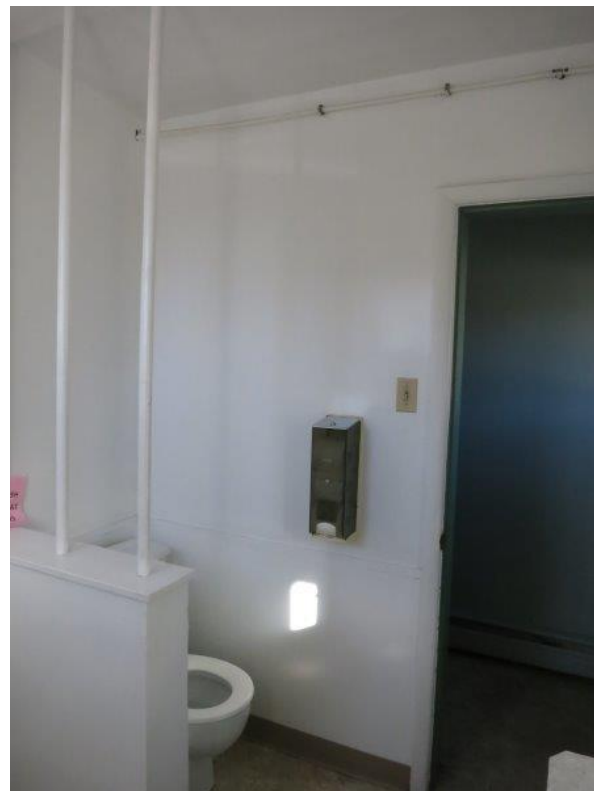
Photo 72 - Men's Washroom is Former Rectory Main Level Washroom.

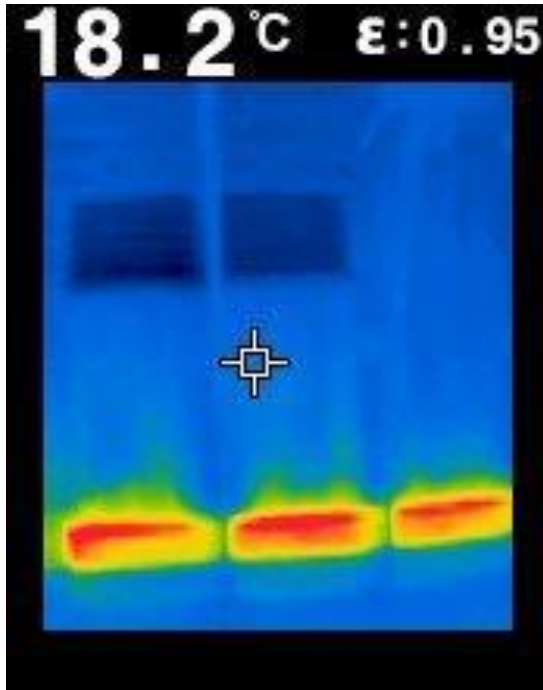
Despite the many instances of blocked or restricted air circulation around many of the heating radiators, the flow through the piping appears to be relatively uniform when scanned with an infrared camera [See Photo 59, Photo 62, Photo 64, Photo 66]. The walls are cooler above the radiators than what might be expected.

Photo 80 - Infrared Image of Hot Water Radiators on West Side of Hall with Wall Temperature at 18.2C

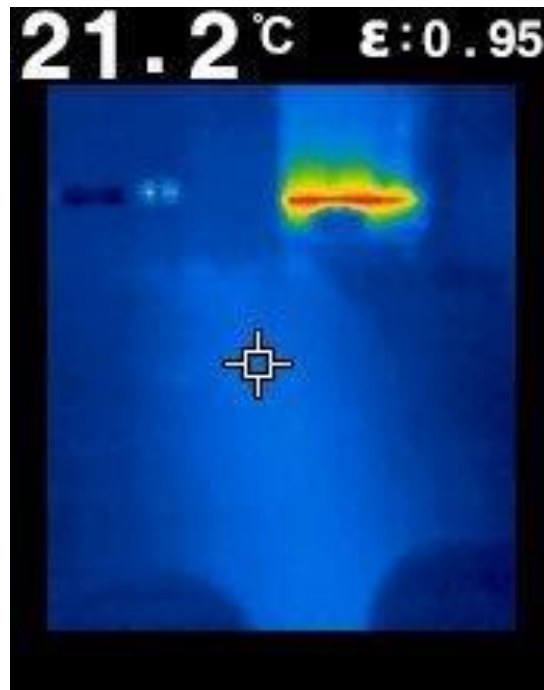
Photo 81 - Infrared Image of Single Radiator with Floor Temperature at 21.2C

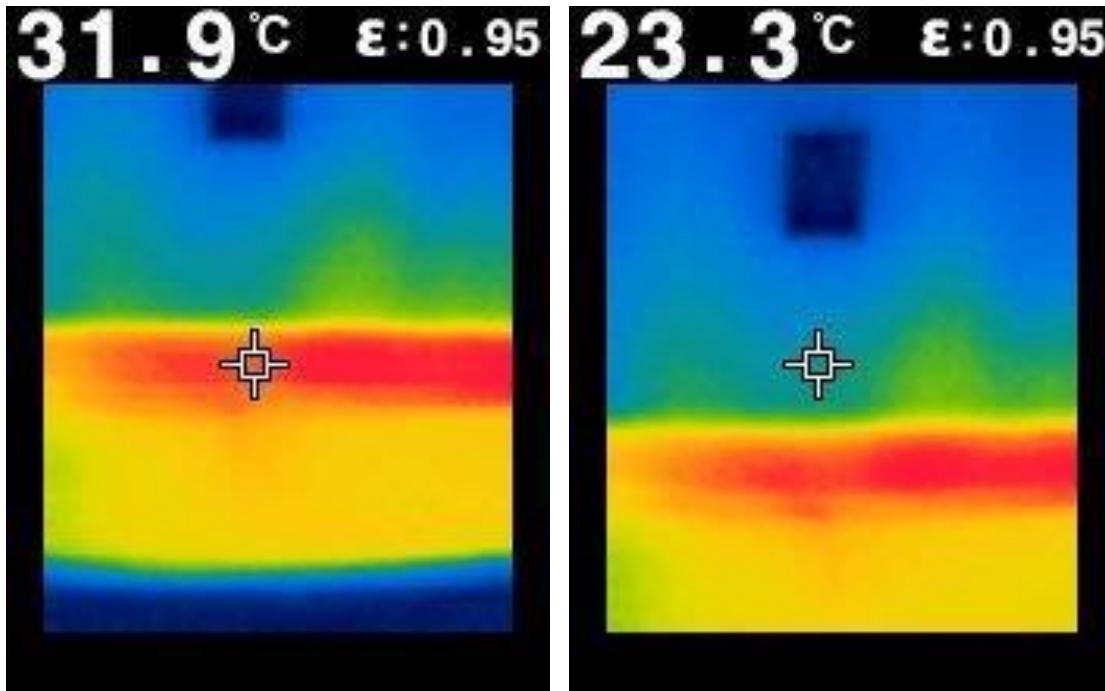
*Photo 82 - Infrared Image of Hot Water Radiator
Surface Temperature = 31.9C*

*Photo 83 - Infrared Image of Exterior Wall
(Temperature 23.3C) Immediately above Hot Water
Radiator*

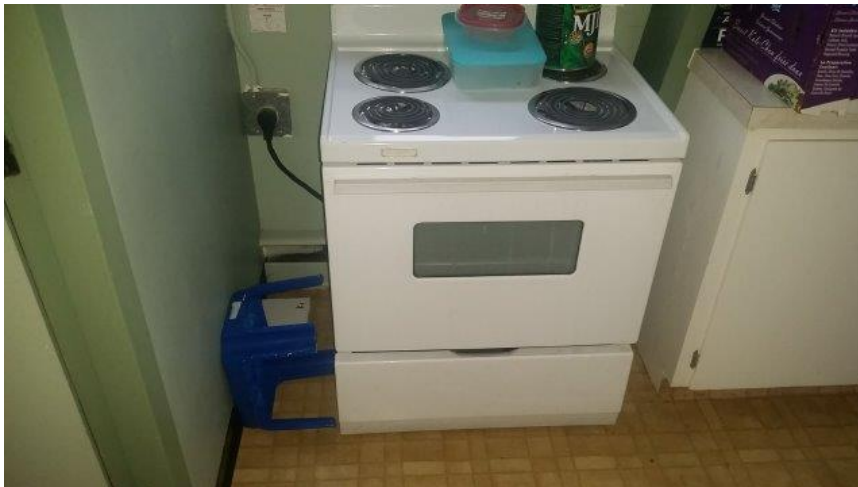
Photo 85 - Kitchen Appliances and Cupboards Blocking Hot Water Heating Radiators

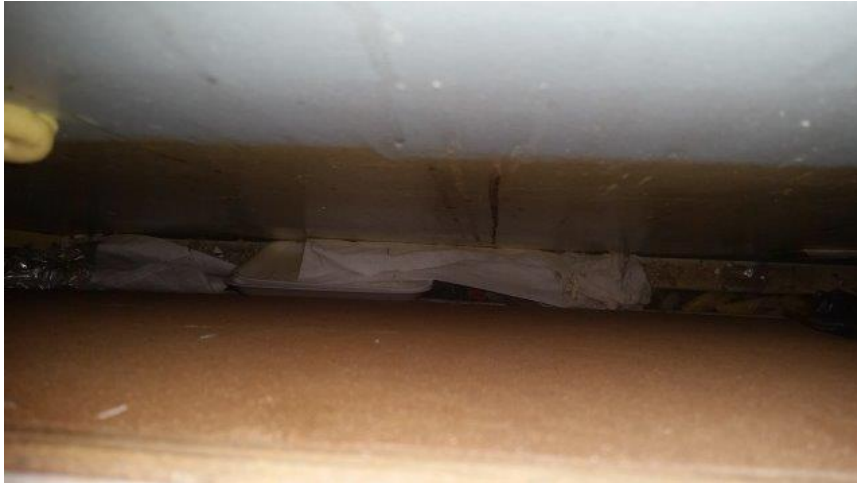
Photo 86 - Looking Down on Kitchen Material on Top of Hot Water Heating Radiators

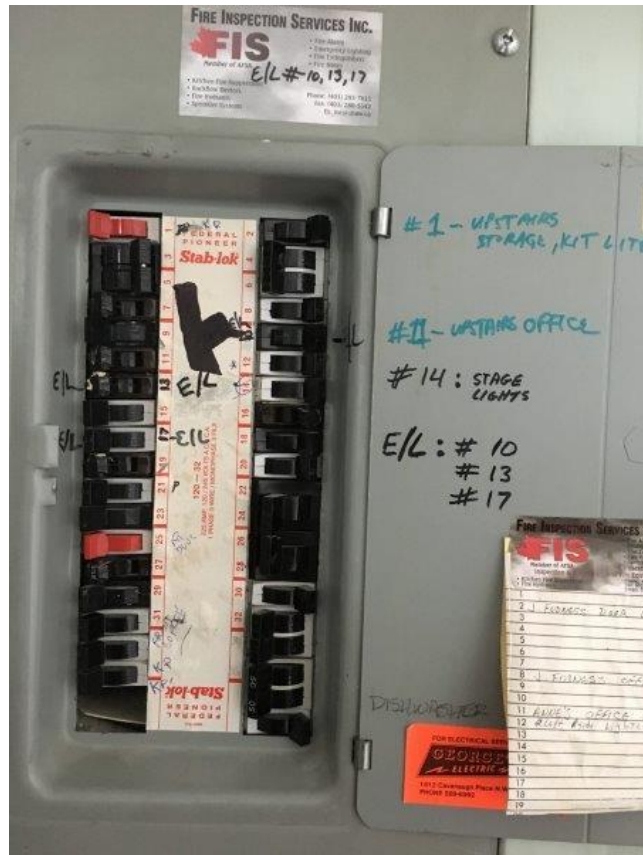
Photo 88 - Circuit Breaker Panel Supplying Hall from Church

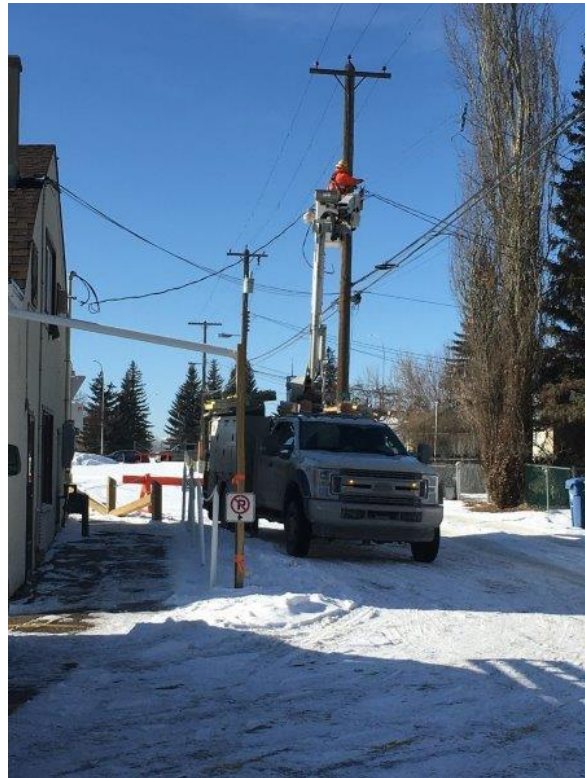
Photo 92 - Utility Required Fused Disconnect Switch to Allow their Linemen to Isolate the Hall Electrical Load from the Utility Supply

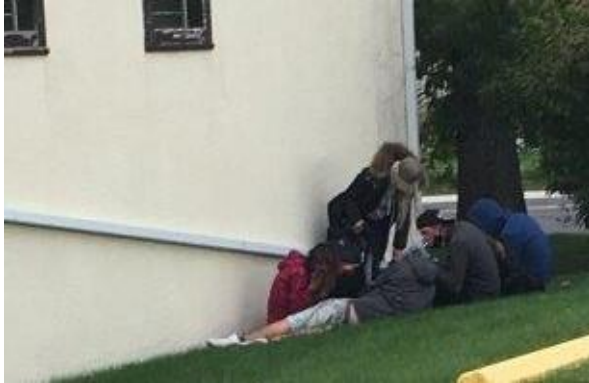
There is no centralized security (or fire alarm) system for the hall.

Photo 93 - Vagrants (6) Smoking Adjacent to the Hall West Wall

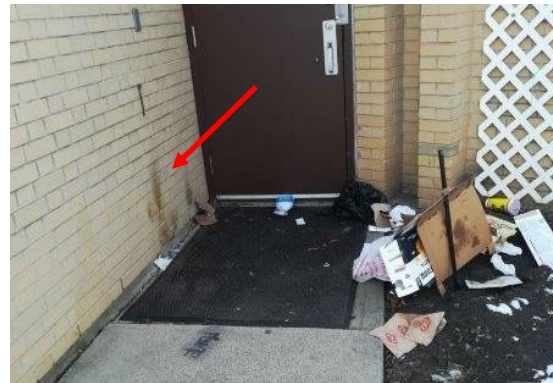
Photo 94 - Vagrant started fire Outside Church

Vandals have previously started small fires outside and adjacent to brick walls of the church, likely in an attempt to keep warm. There haven't been fires started outside the hall so far.
