St Pius X Hall

2424 – 24 Ave NW, Calgary AB

Functional and Physical Condition Assessment

March 16, 2022

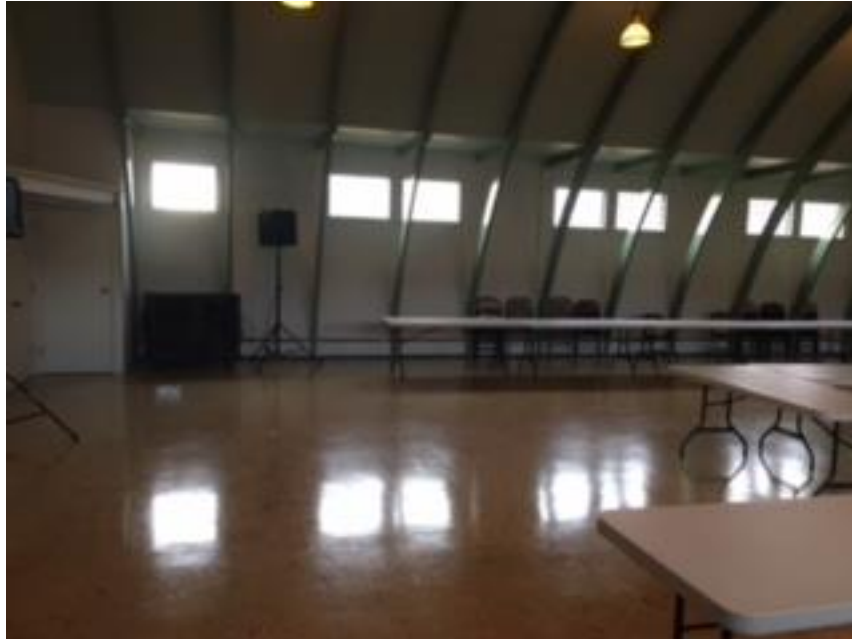
The floor area of the main room in the hall is about 2,200 square feet (204.39 m²); however, the arch ribs intrude into this space leaving about 1,800 square feet (167.23 m²) of usable open space.

The hall footprint occupies a 40'-6 x 86'-0 foot (12.34 x 26.21 m) area for a total building footprint of 3483 square feet (323.58 m²). However, much of this area is taken up by an office, a kitchen, washrooms, storage areas for the main hall, and intrusion of the arch ribs along each side of the main hall by approximately 3 feet.

Photo 7 - Arch Rib Construction along the Straight Walls Intrude into Main Hall Space

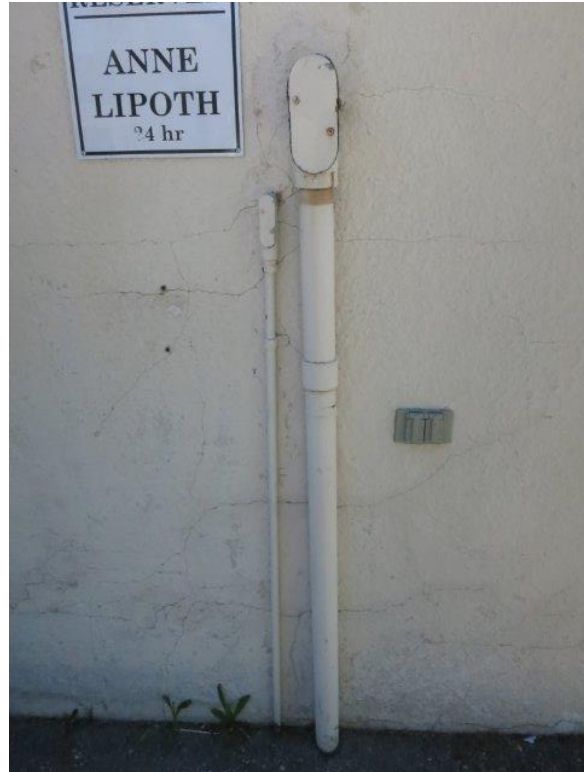
Photo 14 - Holes in Stucco not Sealed

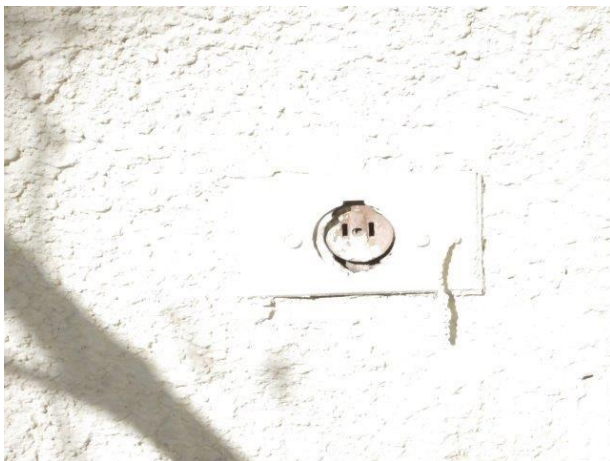
Photo 15 - Unsealed, (and Non Grounded) Electrical Receptacle

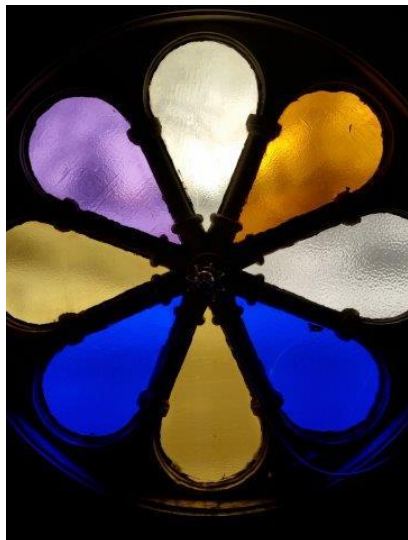
A hand built stained glass circular window above the original church entrance and a feature visible from 24 Ave NW is unfortunately broken, rotting and allowing rain and cold air to enter the hall. It has single pane glass with some panes broken. It is lighted at night by means of a special bulb and a timer.

Photo 26 - Stained Glass Front Window

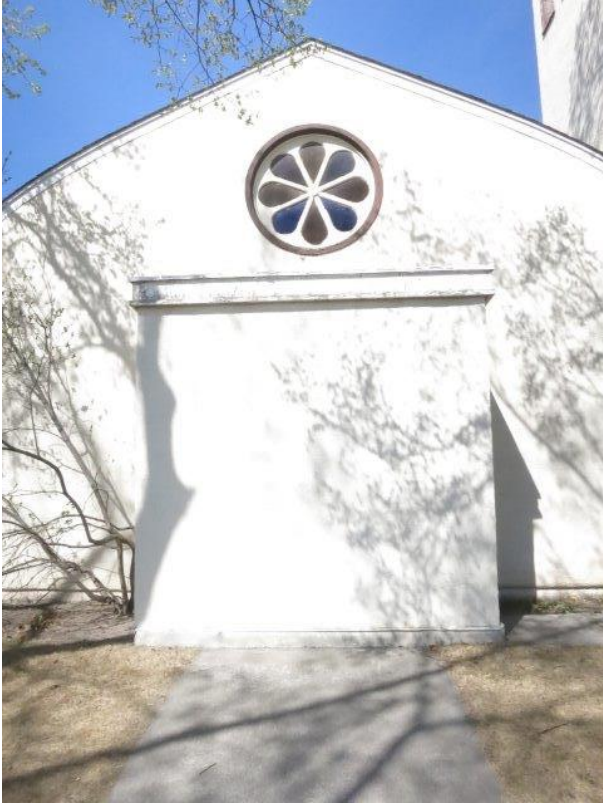
The original hall had an enclosed vestibule type entrance surrounding the front interior entrance door to the hall. At some time, the interior door was sealed off from the outside; however, the inside of the vestibule was never finished on its inside.

Photo 29 - South (Original Main) Entrance to Hall (Now Closed Off)

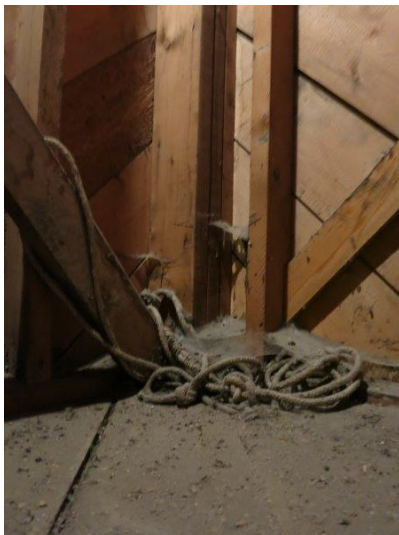
Photo 34 - Interior Debris on Floor of Tower

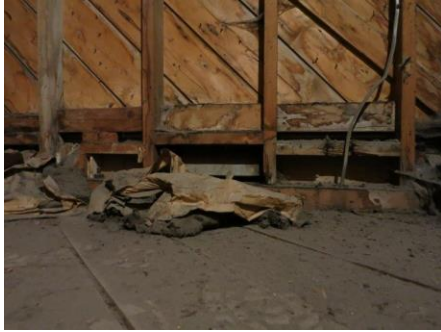
Photo 37 - Debris, Bat, Bird and Mouse Feces

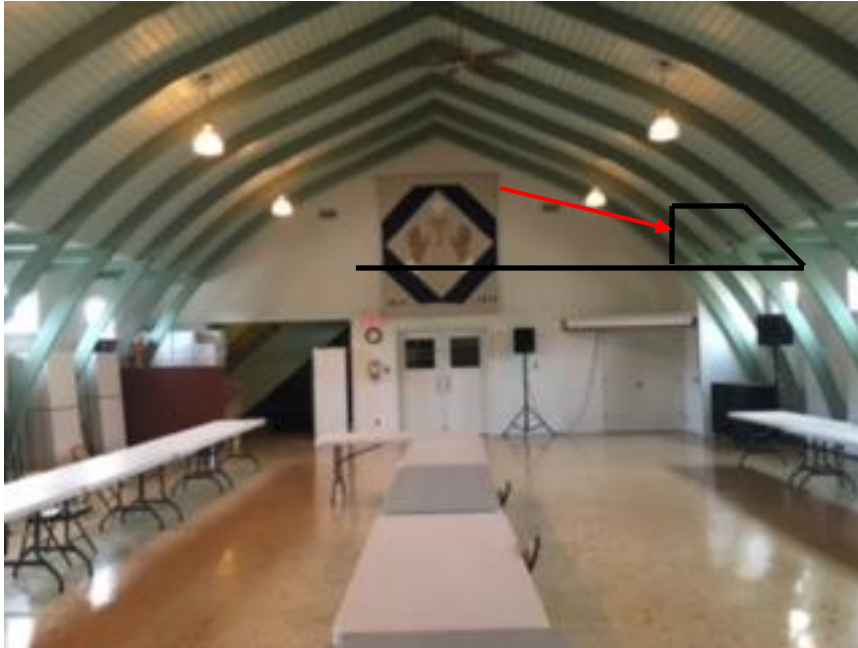
Photo 46 - Location of "Small Storage Room" Over Chair Storage Room

This photo shows the location of a small storage room over the room where chairs are stored at the back of the hall. This room spans three arches, one of which is at the outside south wall facing 24 Ave NW. This room provides a view of the underside of the flat portion of the roof at the SW corner of the hall. It also shows how the south wall incorporates both an arch rib and timber framing construction. There have been no observations to indicate that the north end wall was constructed any differently.

Water damage is evident on the underside of the flat portion of the roof deck.

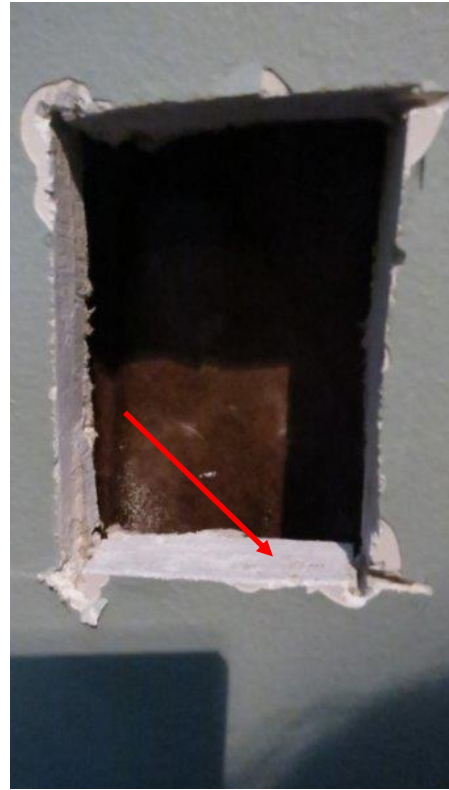
Photo 55 - Hole on Inside Hall Wall where Sample was Taken for Hazardous Material Sampling. Note line between Hardboard and Drywall Materials

The wall cavity was found to contain moderate to low levels of mould in the paper-backed insulation and wall cavity. Informally, the lab associate these levels with a relatively high air flow through the wall, maintaining a dry wall cavity. The wall does have a relatively high leakage rate compared with a building constructed in the present era. Air leakage through walls and high thermal loss means any mould is being kept dry. [Refer to Appendix 16.2]

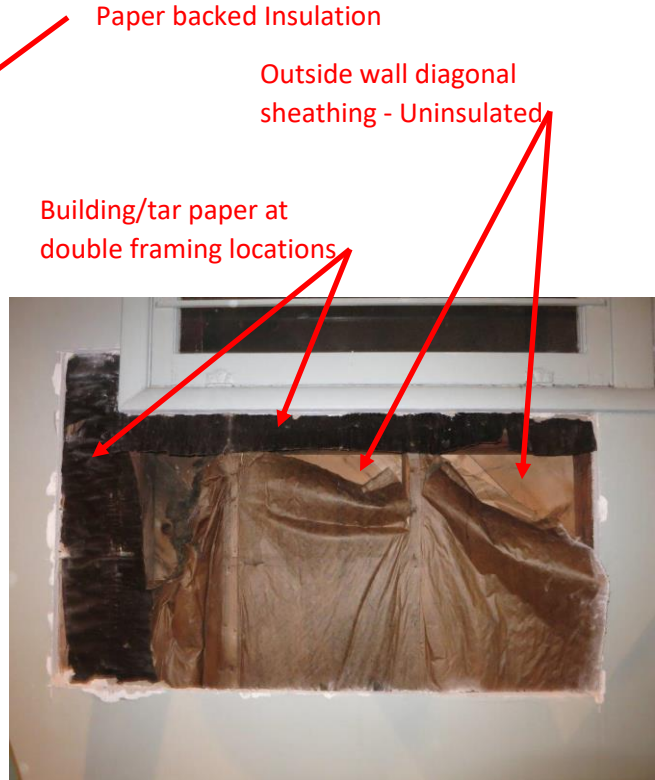
sections of the paper backed insulation. The wall cavity was photographed and the removed samples were sent for laboratory testing. [See Photo 62, Photo 63, Photo 65]

Photo 63 - Paper-Backed Insulation and Building (Tar) Paper Form Vapour Barrier on Inside of Insulation

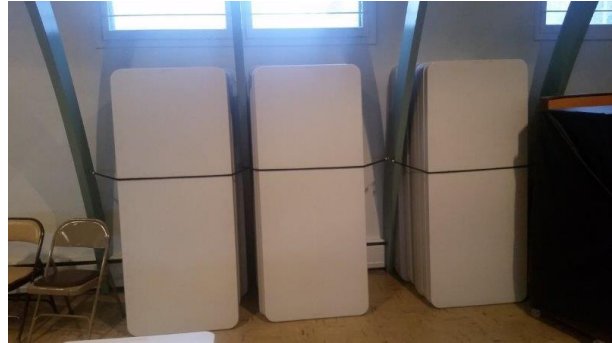
The storage cabinets are generally built into areas along the arch ribs that can't be used effectively as part of the main hall. However, there are many free-standing cabinets and other items that are not secured. The tables, in particular present a falling hazard.

Photo 68 - Tables Stacked Against the Wall in Somewhat Precarious Arrangement

Note that some shelving units are not attached to the walls and could be pulled down accidentally. The tables are not well secured in their “storage positions”; however they are held in position with small bungee cords

Some furnishings require periodic maintenance and are not well designed. An example of this is that some of the tables have no lateral stability. Refer to Photo 68.

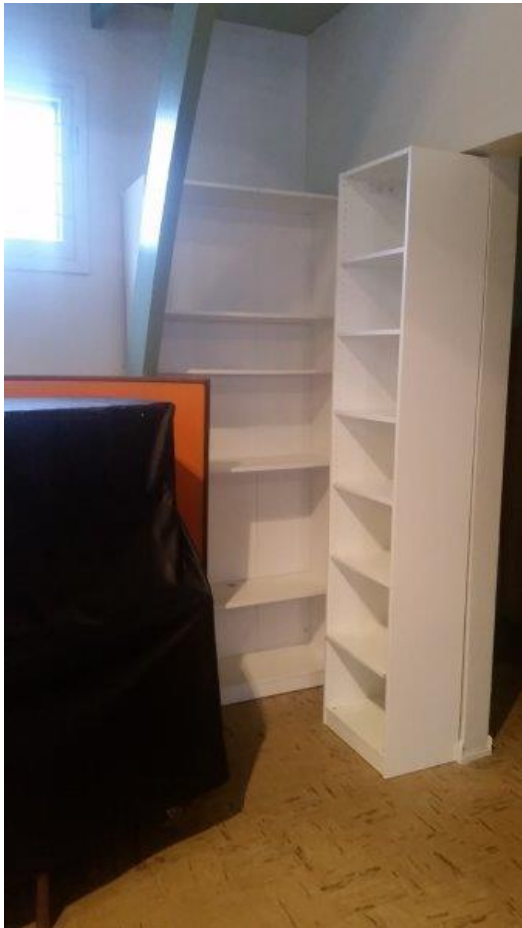
Photo 69 - Combination of Shelving between Arch Ribs and Free Standing.

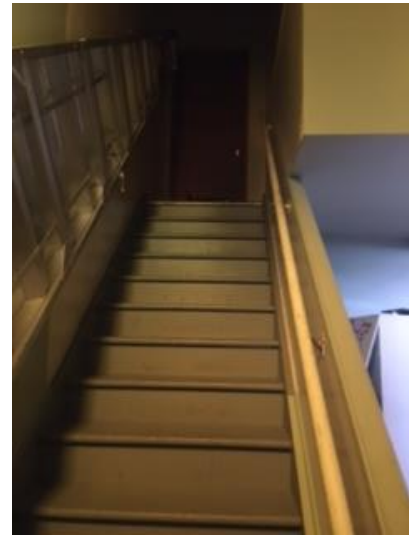
Photo 73 - Stairway to Storage Area over Original Church (Hall) Entrance

However, it should be noted that each of these forms of storage, block the hot water heating radiators. The hall heating system is therefore operating at a suboptimal basis of heat transfer from the heating radiators and the required heating of the hall interior spaces.

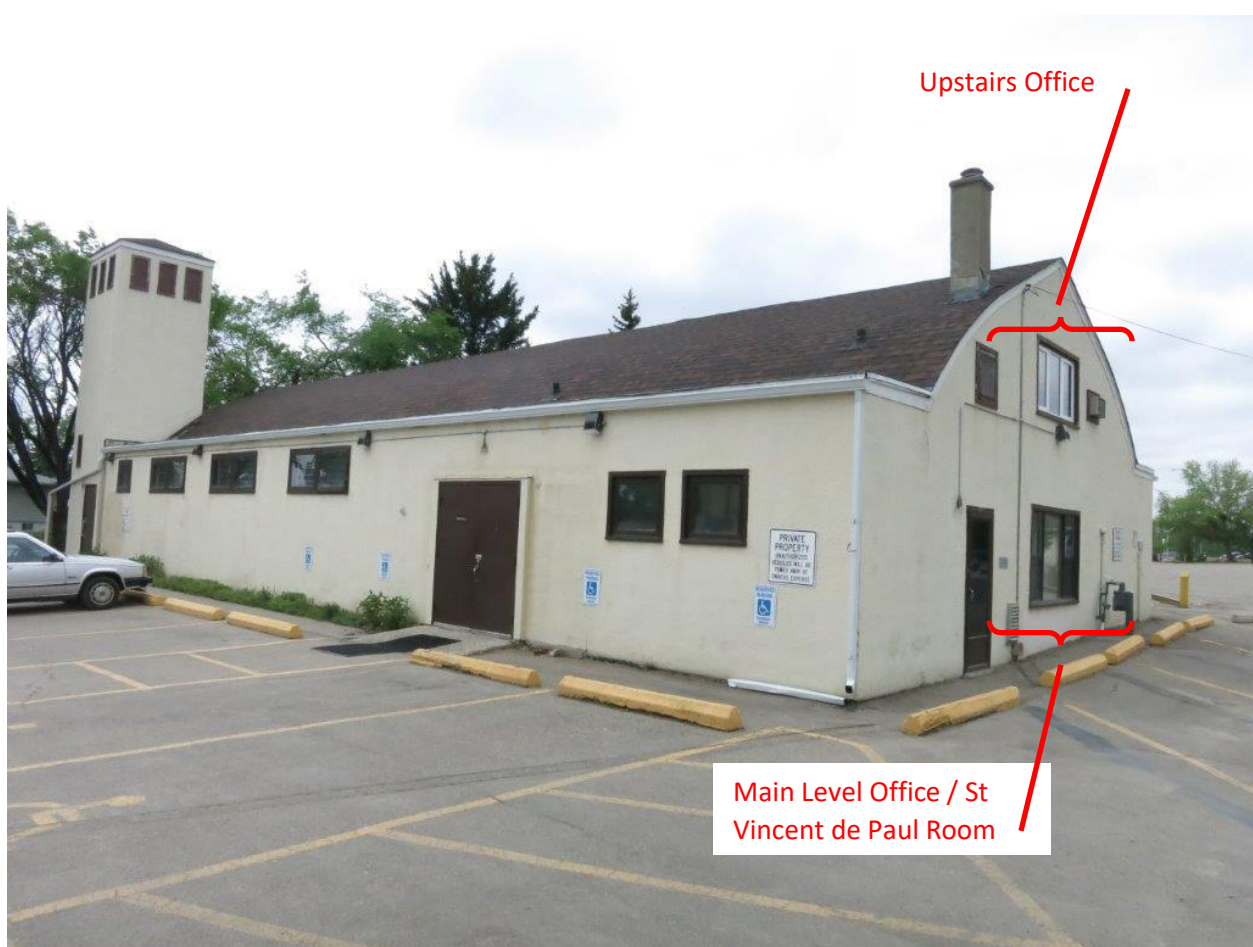
Photo 75 – View of Hall from NE Corner of the Hall (showing upper and lower meeting/office rooms)

We observed that the window in the upstairs office is in quite a deteriorated condition, especially on the outside. The wallboard under the window appears to be in fair condition, especially considering the condition of the outside window frame [See Photo 19]. The outer screen and the window brick mould/trim are in dire need of replacement.

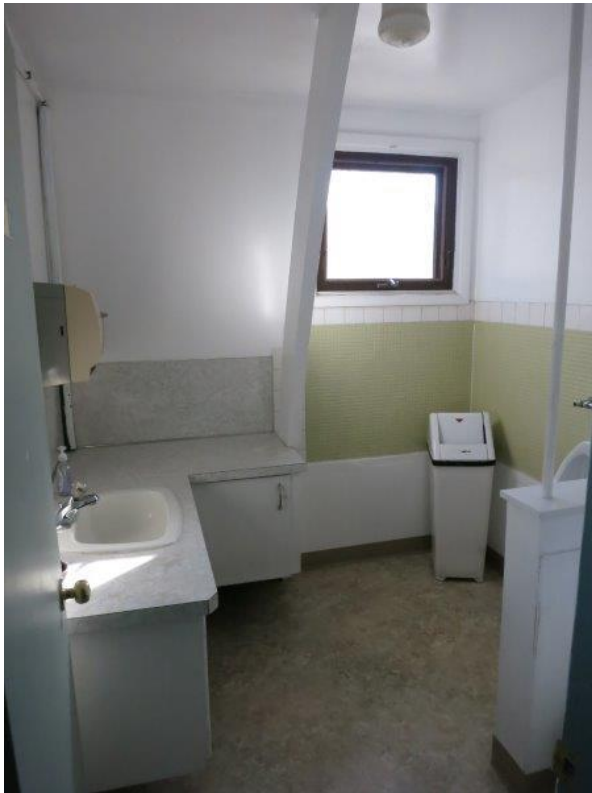
Neither washroom meets accessibility standards or requirement of today [Nor do the washrooms in the church meet accessibility requirement of today].

Photo 79 - Men's Washroom is Former Rectory Main Level Washroom. Tub was where Garbage Can is in Photo

These washrooms were never constructed with a goal of today's accessibility requirements. To achieve accessibility goals, the washrooms would require complete rebuilding and a considerably larger footprint. In addition, access to both washrooms is via quite a narrow hallway.

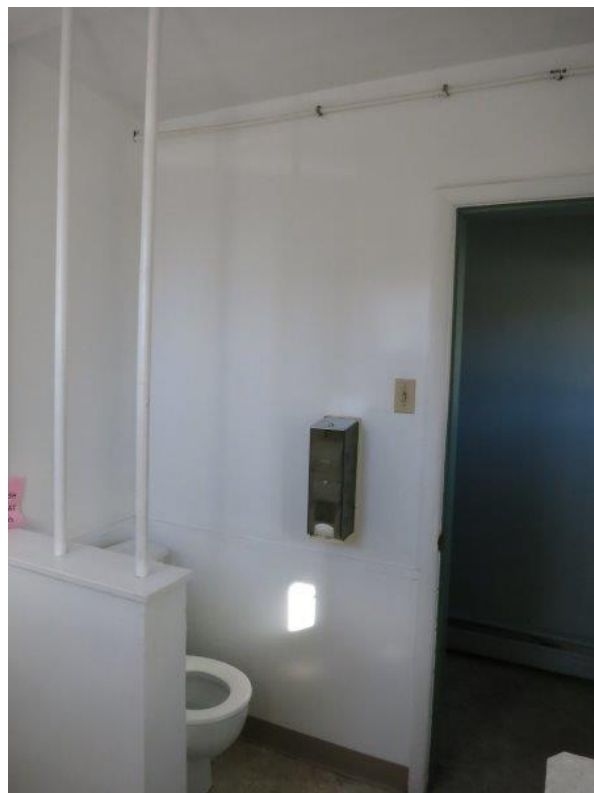
Photo 80 - Men's Washroom is Former Rectory Main Level Washroom.

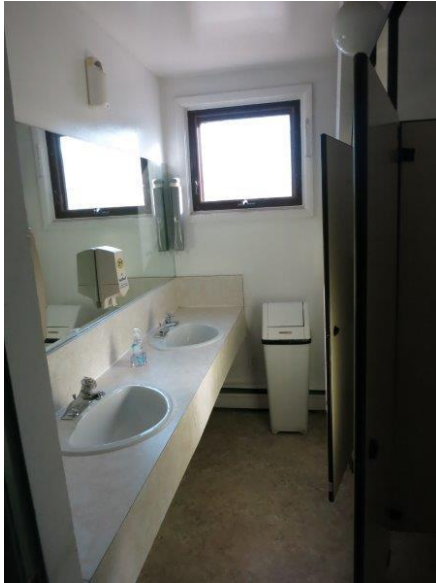
Photo 81 - Women's Washroom was former Church/Hall Washroom

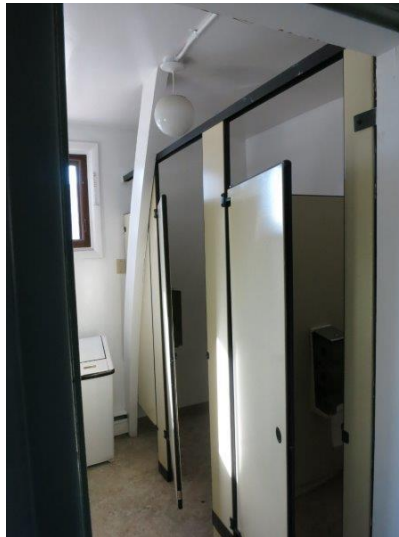
Photo 82 - Narrow and Restricted Non-Accessible Stalls in Women's Washroom

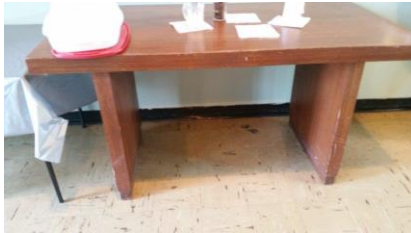
Photo 84 - Tables with no Lateral Stability

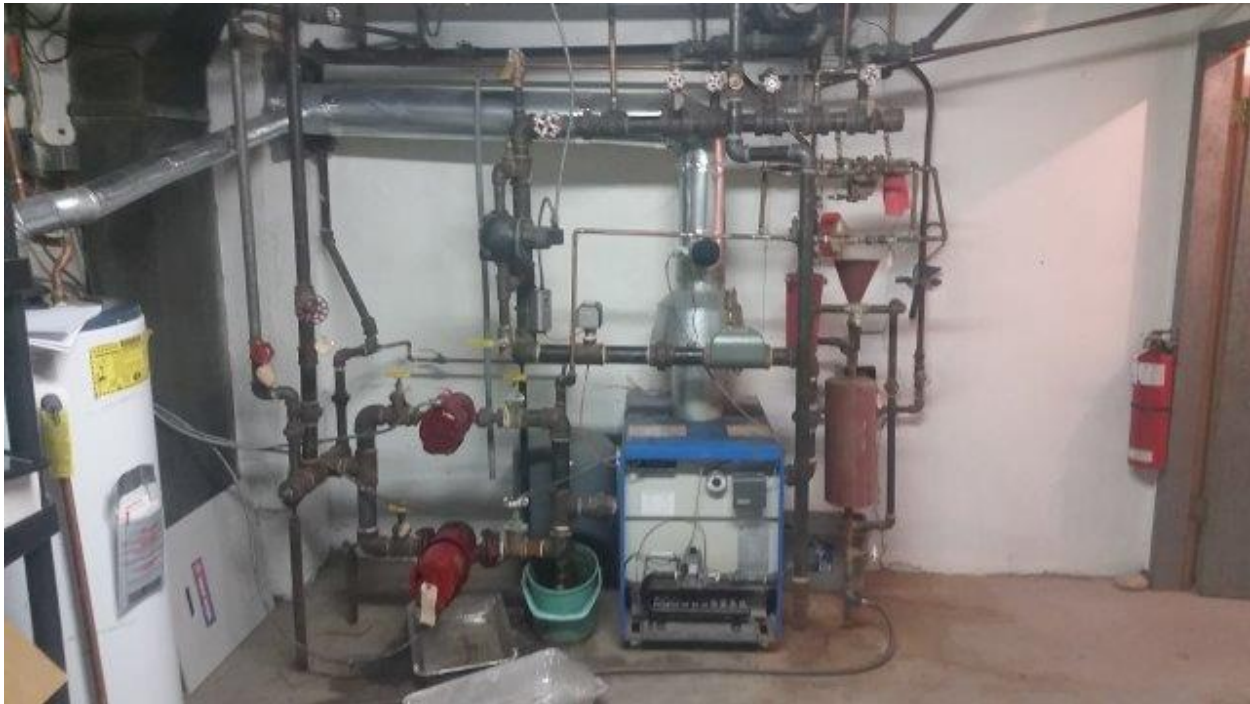
Photo 87 - Hot Water Heating Boiler in Hall Basement

At some point, probably in the 1960s or 1970s, that boiler was replaced with a single pass boiler. The current boiler was installed in 2010 and is now approximately 11 years old. There is no zone valve controlling temperature in the Hall. Hot water is uncontrolled flow or “wild flow”.

There was a chemical pot feeder on the boiler but it seized up and was taken out 2 years ago. A replacement was not ordered because the Hall was expected to be torn down. Passive chemical treatment is introduced into the piping via the filter chamber.

Parging on the chimney is missing exposing the chimney concrete blocks. Flashing at the chimney should be repaired at the next roofing opportunity. There is no indication of chimney liner perforation.

difficult to locate and even more difficult to repair. It is very important to focus on the condition of the heating water. Testing, treatment and maintenance of the chemical condition of the boiler water is very important. An evaluation by a water treatment company and likely a re-installation of the pot feeder is recommended if the hall is to continue in use.

If a replacement boiler system were to be used in the renovated Hall, a glycol 2 pass system would be preferable. Thermostats in key rooms and areas should be used with zone valves. It should come with a chemical feed system and the boiler should be controlled by demand heat (that is the outside temperature plus thermostat settings). It should also have telemetered signals to an operations person off site, since the building is unoccupied for large periods of time.

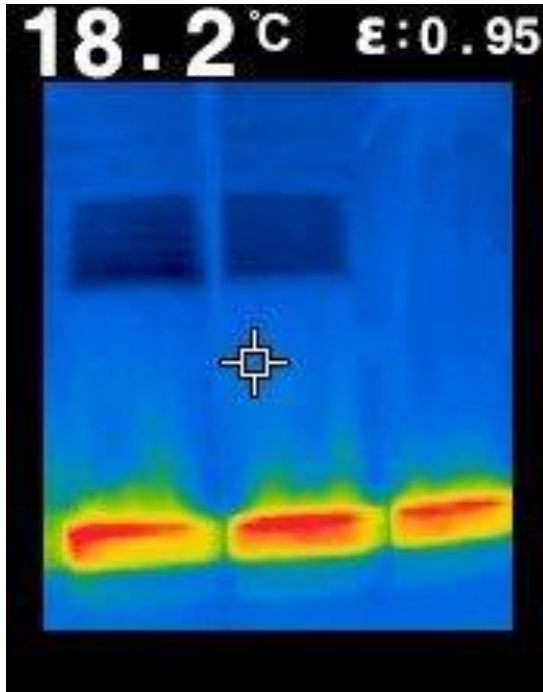
Despite the many instances of blocked or restricted air circulation around many of the heating radiators, the flow through the piping appears to be relatively uniform when scanned with an infrared camera [See Photo 67, Photo 70, Photo 72, and Photo 74]. The walls are cooler above the radiators than what might be expected.

Photo 88 - Infrared Image of Hot Water Radiators on West Side of Hall with Wall Temperature at 18.2C

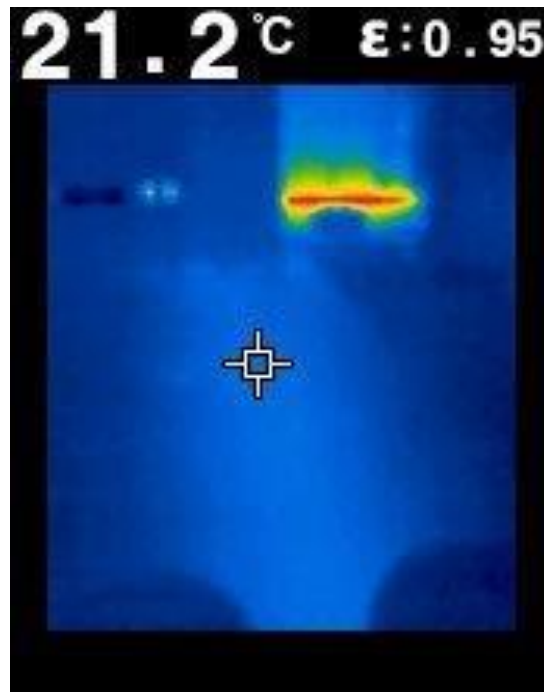
Photo 89 - Infrared Image of Single Radiator with Floor Temperature at 21.2C

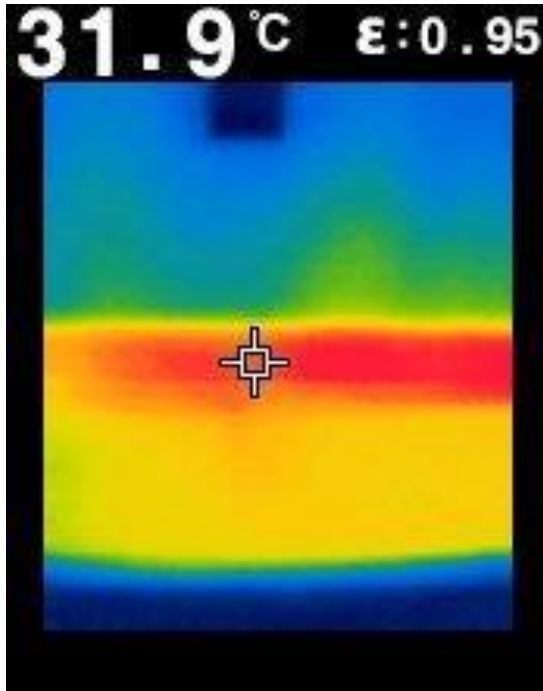
*Photo 90 - Infrared Image of Hot Water Radiator
Surface Temperature = 31.9C*

There is a reasonable temperature difference of 8.6 °C between the top of the hot water radiator and the wall immediately above this radiator. There is of course, heat being transferred to the interior hall space by radiation and convection and heat being lost through the external wall by conduction.

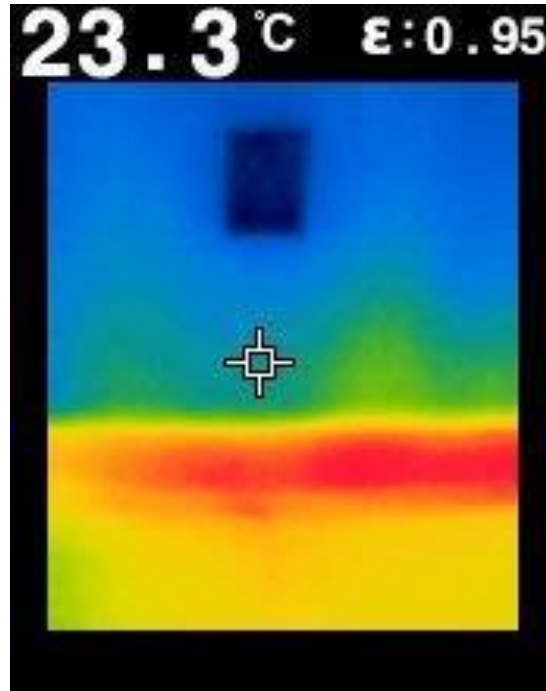
*Photo 91 - Infrared Image of Exterior Wall
(Temperature 23.3C) Immediately above Hot Water
Radiator*

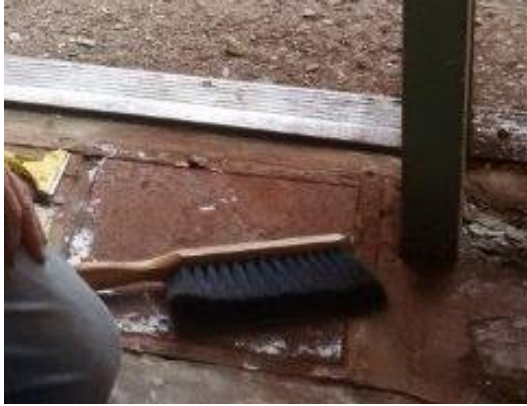
Photo 92 - Access Hatch under Entrance Flooring (with door sill installed)

Other than in the boiler room and these two access hatches, the hot water piping is buried under the concrete floor and is inaccessible.

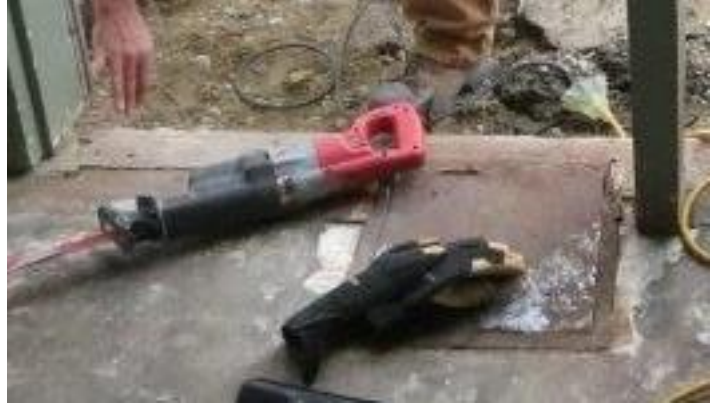
Photo 93 - Access Hatch under Entrance Floor with Door and Frame Removed

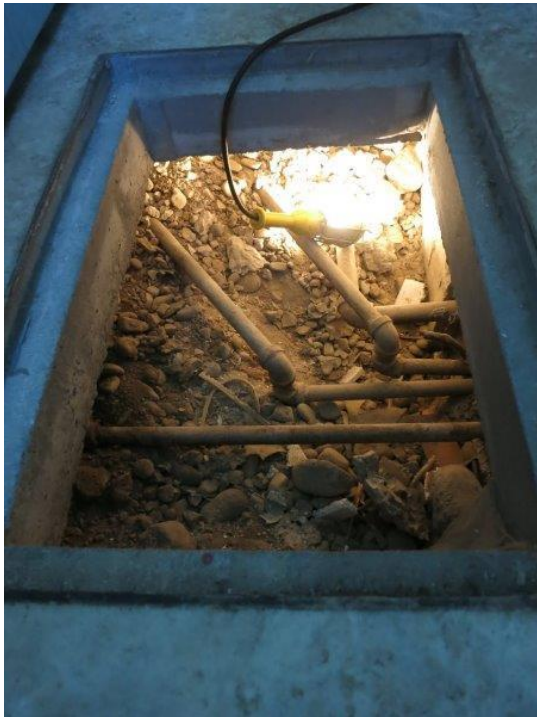
Photo 94 - Access Hatch in Washroom Hallway for Hot Water Piping

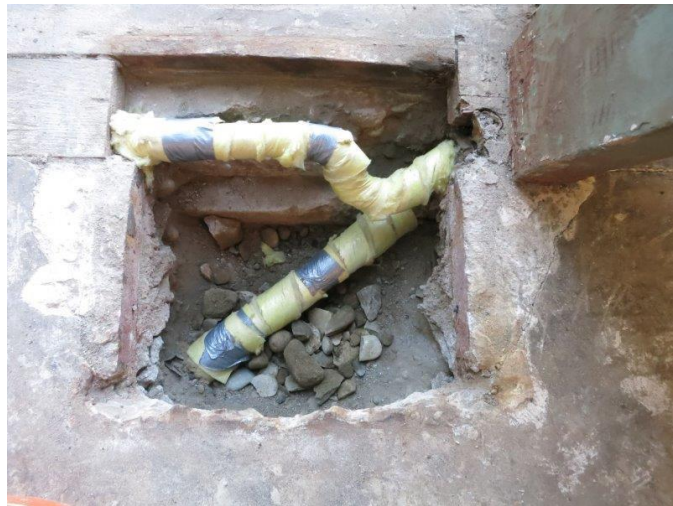
Photo 95 - Hot Water Heating Pipes at East Entrance Door. Insulation Added When Floor was Replaced in 2016 to Keep Pipes from Freezing Near Doorway

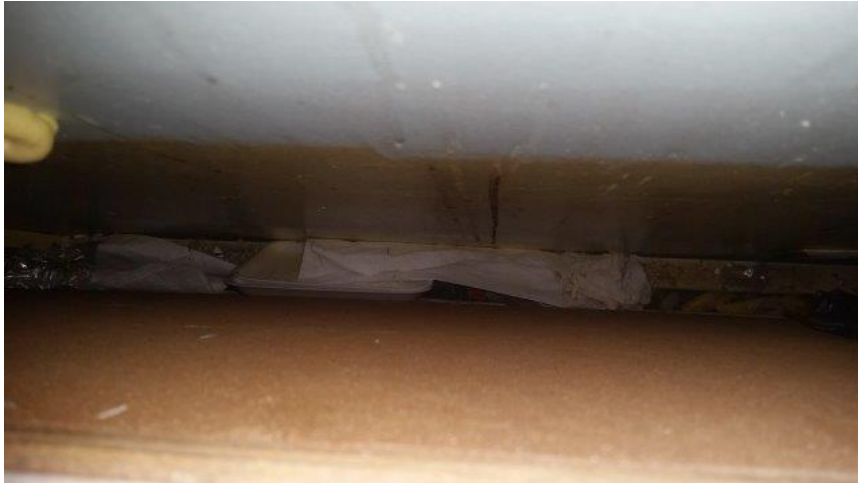
An infrared scan with a FLIR thermal imaging camera indicates relatively even heat distribution along exposed heat radiators. However, there are many objects in front of some heat radiators, which block heat transfer into the main room of the hall.

Photo 98 - Looking Down on Kitchen Material on Top of Hot Water Heating Radiators

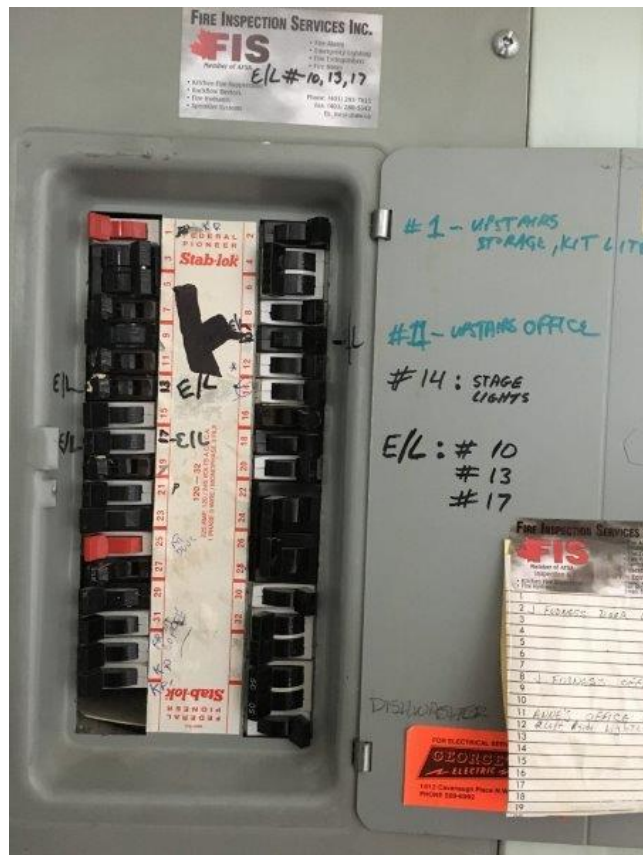
In 2020, the supply cables from the church to the hall short circuited along their underground path. The cables could not be pulled back to the church or to the hall to allow new cables to be pulled in. Subsequent investigation of the church drainage system showed that these cables were installed in steel conduit as they left the church boiler room wall, in No-Corrode or Orangeburg Root-Proof pipe (a form of cardboard and tar derivative (bituminized) pipe used for direct burial sewer service). It was developed to expedite post WWII housing construction and resulted in several hundreds of thousands of miles of pipe failure in sewer service.

Photo 100 - Circuit Breaker Panel Supplying Hall from Church

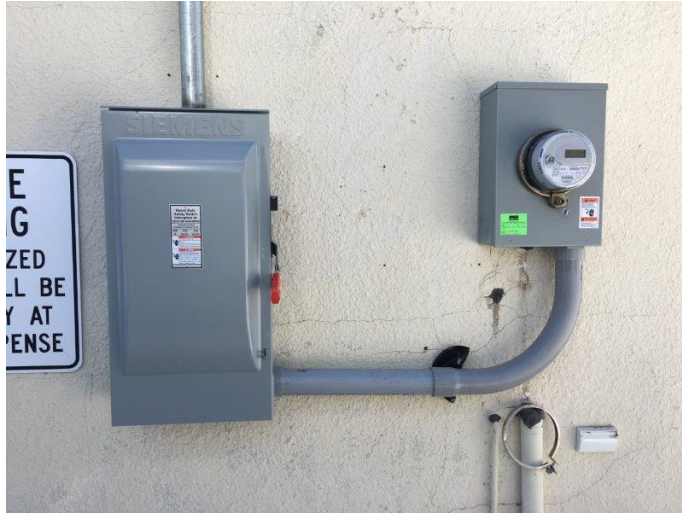
Photo 101 - New (2020) Independent Electrical Supply from Utility

The new service is supplied directly from an overhead ENMAX service line to a master fused safety fused interrupter switch on the exterior north wall of the hall (see Photo 101 and Photo 102).

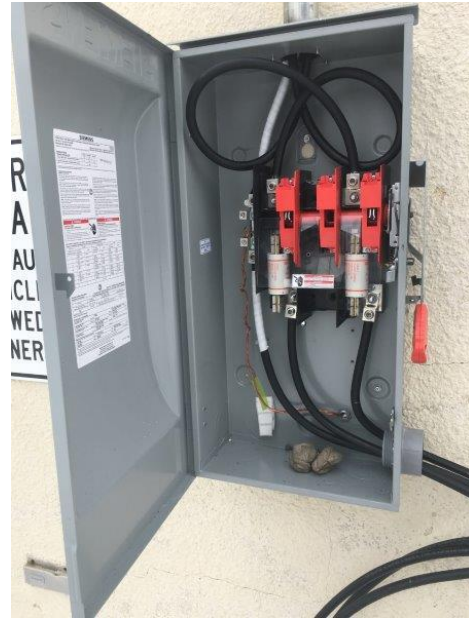
Photo 102 - Fused (200 A) Disconnect Switch to Isolate Hall Electrical Load from Utility

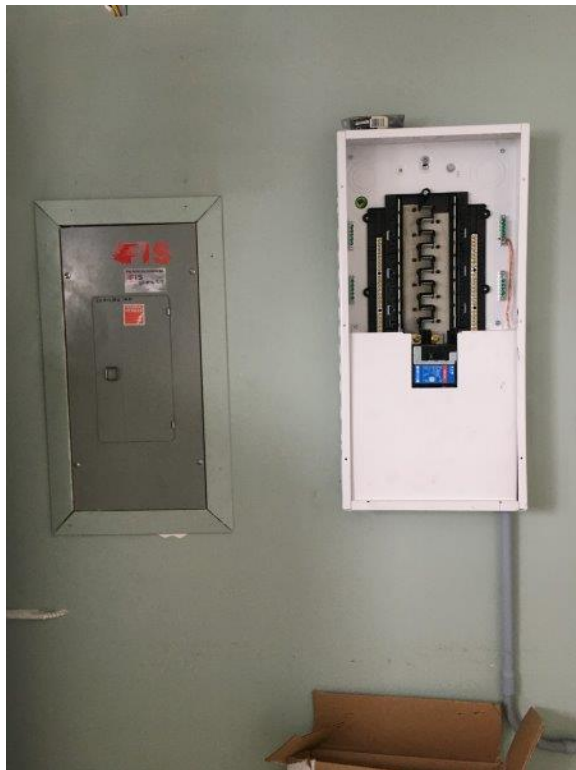
Photo 103 - New 200 A Panel Installed to Connect to Existing Hall Electrical Panel

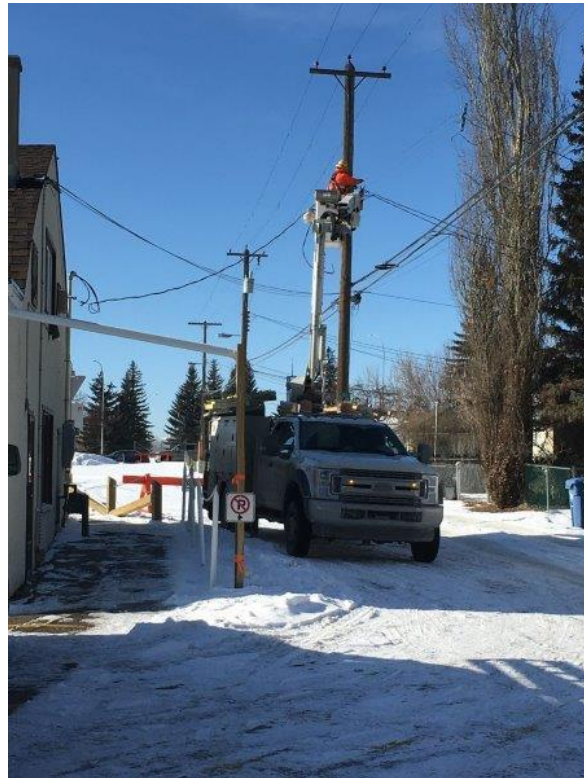
Photo 104 - Utility Required Fused Disconnect Switch to Allow their Linemen to Isolate the Hall Electrical Load from the Utility Supply

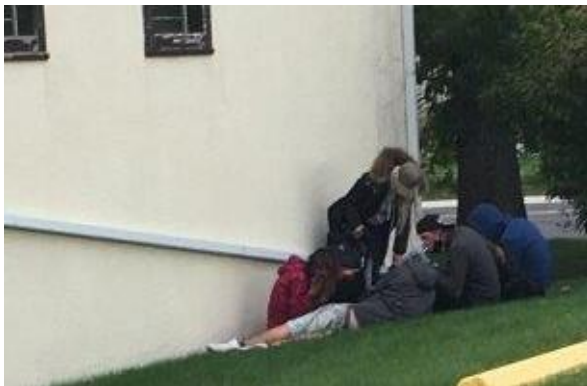
Photo 105 - Vagrants (6) Smoking Adjacent to the Hall West Wall

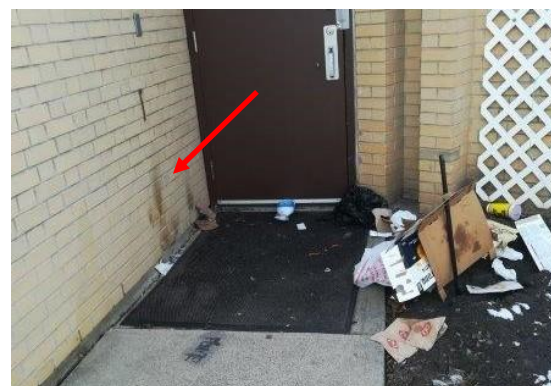
Photo 106 - Vagrant started fire Outside Church

Vandals have previously started small fires outside and adjacent to brick walls of the church, likely in an attempt to keep warm. There haven’t been fires started outside the hall so far.
